Access Compliance Report

Public Rights-of-Way

(Curb Ramps)

Intersection ID: 15321	Main Street: CRESTRIDGE_DR	Cross Street: BRIANNA_WY	Location:	N
ADA ID: 65BDBEBB6EC4	Ramp Type: Perpendicular Diagonal	Initial Pass/Fail: Fail	Overall Compliance: No	Severity Score: 31.25

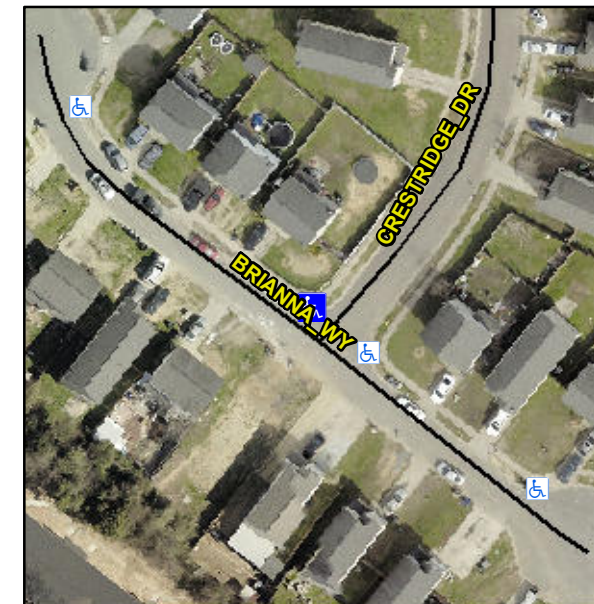
Compliance	Description	Data	Compliance	Description	Data
N/A	Ramp Length (in)	46.0	No	Ramp Slope (%)	8.7
No	Ramp Width (in)	35.0	No	Ramp XSlope (%)	3.0
N/A	Flare Type LT	N/A	N/A	Flare Type RT	N/A
N/A	Flare Slope LT (%)	N/A	N/A	Flare Slope RT (%)	N/A
N/A	Flare Traversable LT?	N/A	N/A	Flare Traversable RT?	N/A
N/A	Landing Length (in)	N/A	N/A	DWS Provided?	N/A
N/A	Landing Width (in)	N/A	N/A	DWS Contrast?	N/A
N/A	Landing Slope (%)	N/A	N/A	DWS Length (in)	N/A
N/A	Landing X Slope (%)	N/A	N/A	DWS Full Width?	N/A
N/A	Landing Curb? (Y/N)	N/A	N/A	DWS Offset (in)	N/A
N/A	Shared Landing?	N/A			
N/A	Gutter Ponding?	N/A	N/A	Gutter Slope (%)	N/A
N/A	Gutter Lip Ht (in)	N/A	N/A	Gutter X Slope (%)	N/A
N/A	Painted X Walk1?	No	N/A	Painted X Walk2?	No
	X Walk 1 Direction	To SW		X Walk 2 Direction	To SE
N/A	X Walk 1 Width (in)	N/A	N/A	X Walk 2 Width (in)	N/A
	X Walk 1 Slope (%)	2.6		X Walk 2 Slope (%)	0.1
	X Walk 1 X Slope (%)	0.1		X Walk 2 X Slope (%)	3.1

N/A	Ramp inside XWalk1?	N/A	N/A	Ramp inside XWalk2?	N/A
	Road Slope (%)	2.3	N/A	Clear Space?	N/A
	Road X Slope (%)	2.3	N/A	Clear Space to XWalk (in)	N/A
N/A	Any Obstructions?	N/A	N/A	Storm Grate/Utility Hazard?	N/A
	Obstruction Type			Storm Grate/Utility Type	
		N/A			N/A
			Yes	Surface Condition? (G/P)	Good

Possible Solutions:

Remove & Replace Curb Ramp With Two New Directional Ramps or Equivalent.
