Access Compliance Report

Public Rights-of-Way

(Curb Ramps)

Intersection ID: 12160	Main Street: E_9TH_ST	Cross Street: N_BREVARD_ST	Location: W
ADA ID: 65C328ADCEC7	Ramp Type: Perpendicular	Initial Pass/Fail: Fail	Overall Compliance: No
Severity Score: 12.5			
Codes/Mitigation Info/Possible Solution		Field Measurements/Component Compliance

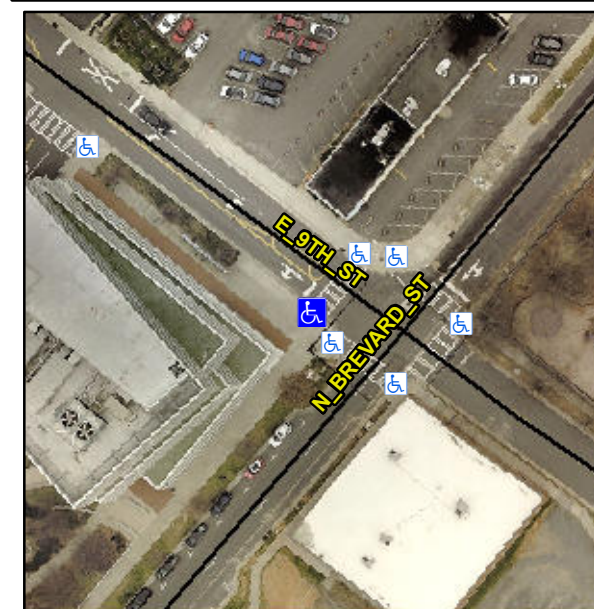
Compliance	Description	Data	Compliance	Description	Data
N/A	Ramp Length (in)	72.0	No	Ramp Slope (%)	8.8
Yes	Ramp Width (in)	48.0	Yes	Ramp XSlope (%)	1.9
N/A	Flare Type LT	N/A	N/A	Flare Type RT	N/A
N/A	Flare Slope LT (%)	N/A	N/A	Flare Slope RT (%)	N/A
N/A	Flare Traversable LT?	N/A	N/A	Flare Traversable RT?	N/A
N/A	Landing Length (in)	N/A	N/A	DWS Provided?	N/A
N/A	Landing Width (in)	N/A	N/A	DWS Contrast?	N/A
N/A	Landing Slope (%)	N/A	N/A	DWS Length (in)	N/A
N/A	Landing X Slope (%)	N/A	N/A	DWS Full Width?	N/A
N/A	Landing Curb? (Y/N)	N/A	N/A	DWS Offset (in)	N/A
N/A	Shared Landing?	N/A			
N/A	Gutter Ponding?	N/A	N/A	Gutter Slope (%)	N/A
N/A	Gutter Lip Ht (in)	N/A	N/A	Gutter X Slope (%)	N/A
N/A	Painted X Walk1?	Yes	N/A	Painted X Walk2?	N/A
	X Walk 1 Direction	To NE		X Walk 2 Direction	N/A
N/A	X Walk 1 Width (in)	104.0	N/A	X Walk 2 Width (in)	N/A
	X Walk 1 Slope (%)	3.8		X Walk 2 Slope (%)	N/A
	X Walk 1 X Slope (%)	2.2		X Walk 2 X Slope (%)	N/A

N/A	Ramp inside XWalk1?	Yes	N/A	Ramp inside XWalk2?	N/A
	Road Slope (%)	N/A	N/A	Clear Space?	N/A
	Road X Slope (%)	N/A	N/A	Clear Space to XWalk (in)	N/A
N/A	Any Obstructions?	N/A	N/A	Storm Grate/Utility Hazard?	N/A
	Obstruction Type			Storm Grate/Utility Type	
		N/A			N/A
		Yes		Surface Condition? (G/P)	Good

Possible Solutions:

Remove & Replace Entire Ramp.

Not Found, R304.2.2
