Access Compliance Report

Public Rights-of-Way

(Curb Ramps)

Intersection ID: N/A	Main Street: INDEPENDENCE_RD	Cross Street: N/A	Location: E
ADA ID: 65C694CD897A	Ramp Type: Directional1	Initial Pass/Fail: Pass	Overall Compliance: No
		Severity Score: 10

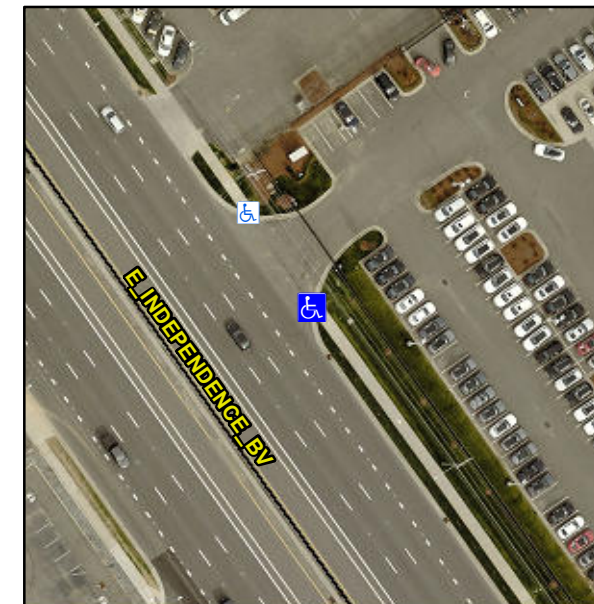
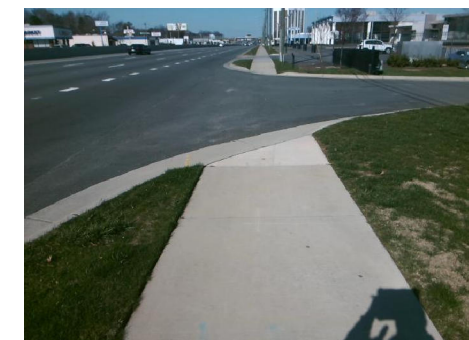
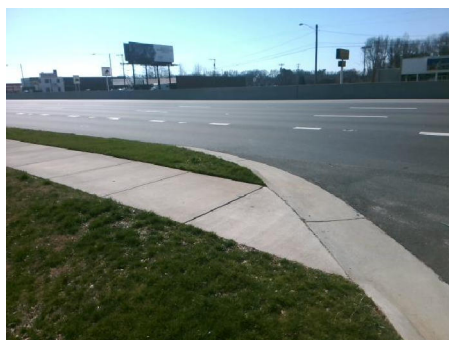
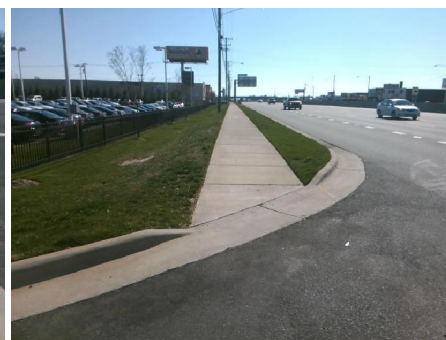
**Not Found, R304.2.2-Perp, R304.3.2-
Para, R304.5.2, R305, R304.5.3**

Compliance	Description	Data	Compliance	Description	Data
N/A	Ramp Length (in)	65.0	No	Grade Break?	No
Yes	Ramp Width (in)	72.0	N/A	Grade Break Slope (%)	3.0
Yes	Ramp Slope (%)	2.9	N/A	Grade Break XSlope (%)	0.9
Yes	Ramp XSlope (%)	1.4			
N/A	Flare Type LT	N/A	N/A	Flare Type RT	N/A
N/A	Flare Slope LT (%)	N/A	N/A	Flare Slope RT (%)	N/A
N/A	Flare Traversable LT?	N/A	N/A	Flare Traversable RT?	N/A
Yes	Landing Length (in)	63.0	No	DWS Provided?	No
Yes	Landing Width (in)	72.0	N/A	DWS Contrast?	No
No	Landing Slope (%)	2.3	N/A	DWS Length (in)	N/A
Yes	Landing X Slope (%)	0.9	N/A	DWS Full Width?	No
N/A	Landing Curb? (Y/N)	N/A	N/A	DWS Offset LT (in)	N/A
N/A	Shared Landing?	No	N/A	DWS Offset RT (in)	N/A
Yes	Gutter Ponding?	No	Yes	Gutter Slope (%)	0.4
Yes	Gutter Lip Ht (in)	0.0	No	Gutter X Slope (%)	2.4
N/A	Painted X Walk1?	No		Road Slope (%)	1.2
	X Walk 1 Direction	To NW		Road X Slope (%)	1.2
	X Walk 1 Width (in)	N/A		Clear Space?	Yes

X Walk 1 Slope (%)	1.2	N/A	Clear Space to XWalk (in)	N/A
	X Walk 1 X Slope (%)	1.2	Yes	Storm Grate/Utility Hazard?	No
N/A	Ramp inside XWalk1?	N/A		Storm Grate/Utility Type	
Yes	Any Obstructions?	No			N/A
	Obstruction Type		Yes	Surface Condition? (G/P)	Good
			N/A	Curb Slope (%)	15.9

**Remove & Replace Entire Ramp.
Remove & Replace Gutter.**

Total Cost: \$ 2350.00
