# Access Compliance Report

## Public Rights-of-Way

| Intersection ID: 4264 | Main Street: MT_HOLLY-HUNTERSVILLE_RD | Cross Street: OVERLOOK_MOUNTAIN_DR | Location: SW |
| ADA ID: 65CECA052733 | Ramp Type: Perpendicular | Initial Pass/Fail: Fail | Overall Compliance: No |

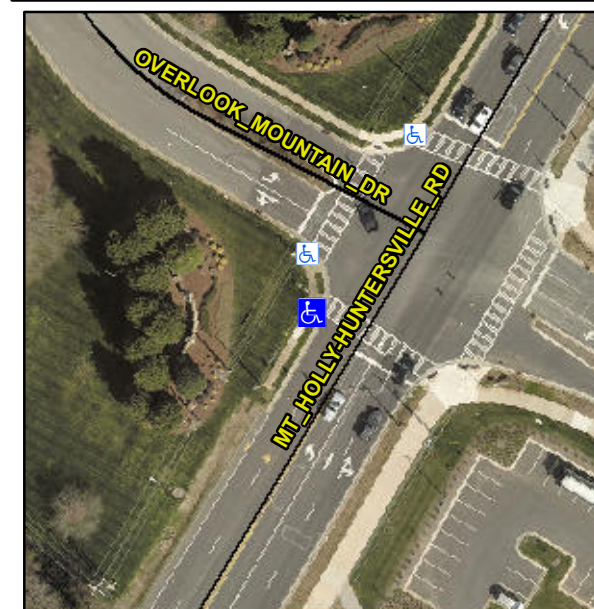
| Codes/Mitigation Info/Possible Solution | | | Severity Score: 25 |

**Not Found, R304.2.2**

| Compliance | Description | Data | Compliance | Description | Data |
|---|---|---|---|---|---|
| N/A | Ramp Length (in) | 48.0 | No | Ramp Slope (%) | 12.4 |

**Remove & Replace Entire Ramp.**

Total Cost: \$ 1850.00

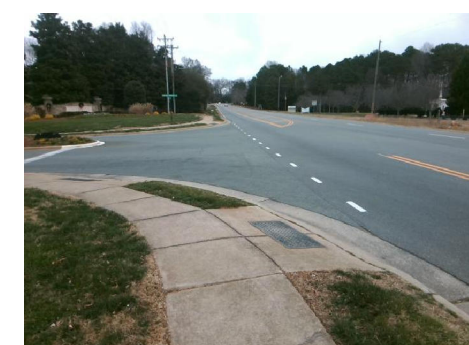
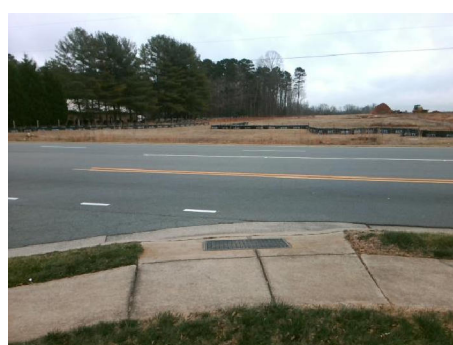
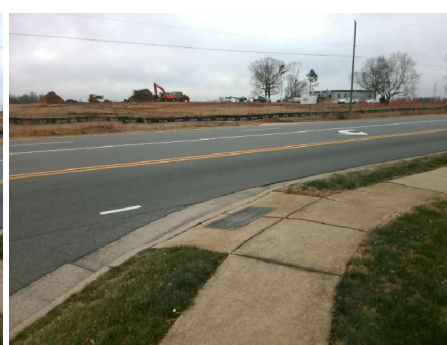
| Compliance | Description | Data | Compliance | Description | Data |
|---|---|---|---|---|---|
| | | | Yes | Surface Condition? (G/P) | Good |
