## **Access Compliance Report Public Rights-of-Way** (Curb Ramps)

Intersection ID: N/A Main Street: TYVOLA RD **Cross Street: SPEER BV** Location: W Initial Pass/Fail: Pass **Overall Compliance: No Severity Score:** 0 **ADA ID: 65DA013FF44D** Ramp Type: Perpendicular

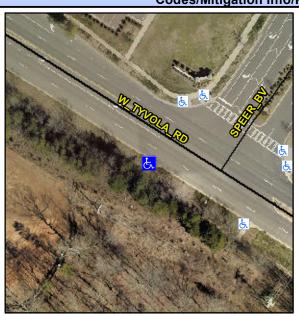
W TYVOLA RD Street 1 Name Stop Condition-Street 2 None N/A Street 2 Name Stop Condition-Street 1 N/A Possible Solutions: Remove & Replace Entire Ramp. Surveyor Notes: N/A PROW/ADA: Not Found, R304.2.2-Perp, R304.3.2-Para
