Access Compliance Report

Public Rights-of-Way

(Curb Ramps)

Intersection ID: 26825	Main Street: OAK_POND_CR	Cross Street: SUMMERSTON_PL	Location: NW
ADA ID: 65DD80AF1CF3	Ramp Type: Perpendicular Diagonal	Initial Pass/Fail: Fail	Overall Compliance: No
Severity Score: 12.5			
Codes/Mitigation Info/Possible Solution		Field Measurements/Component Compliance

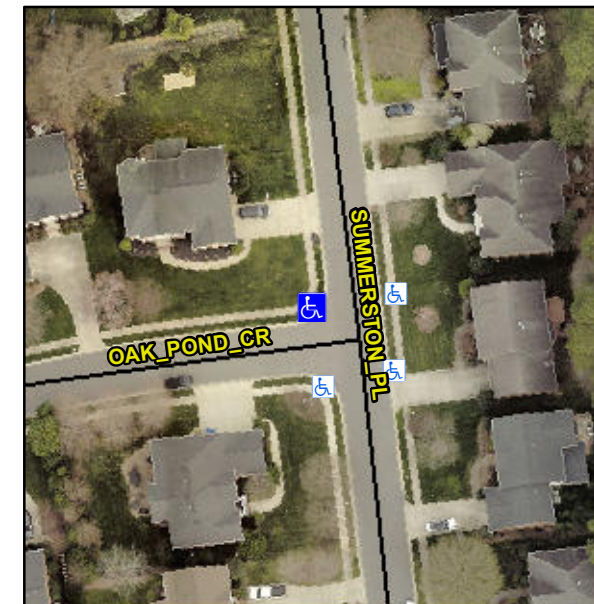
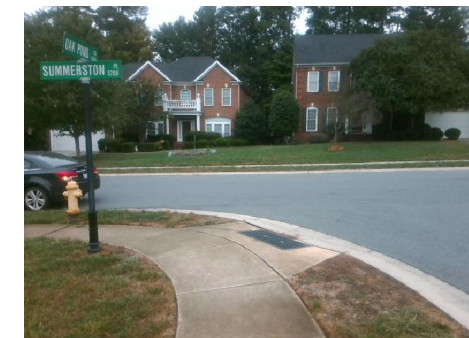
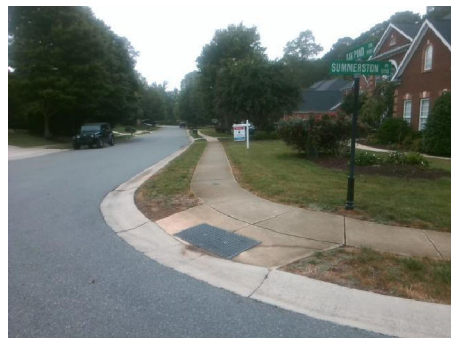
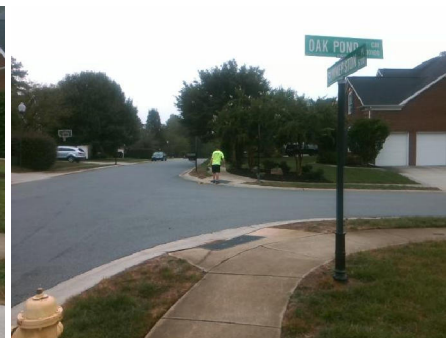
Compliance	Description	Data	Compliance	Description	Data
N/A	Ramp Length (in)	43.0	No	Ramp Slope (%)	10.5
Yes	Ramp Width (in)	48.0	Yes	Ramp XSlope (%)	2.0
N/A	Flare Type LT	N/A	N/A	Flare Type RT	N/A
N/A	Flare Slope LT (%)	N/A	N/A	Flare Slope RT (%)	N/A
N/A	Flare Traversable LT?	N/A	N/A	Flare Traversable RT?	N/A
N/A	Landing Length (in)	N/A	N/A	DWS Provided?	N/A
N/A	Landing Width (in)	N/A	N/A	DWS Contrast?	N/A
N/A	Landing Slope (%)	N/A	N/A	DWS Length (in)	N/A
N/A	Landing X Slope (%)	N/A	N/A	DWS Full Width?	N/A
N/A	Landing Curb? (Y/N)	N/A	N/A	DWS Offset (in)	N/A
N/A	Shared Landing?	N/A			
N/A	Gutter Ponding?	N/A	N/A	Gutter Slope (%)	N/A
N/A	Gutter Lip Ht (in)	N/A	N/A	Gutter X Slope (%)	N/A
N/A	Painted X Walk1?	No	N/A	Painted X Walk2?	No
	X Walk 1 Direction	To S		X Walk 2 Direction	To E
N/A	X Walk 1 Width (in)	N/A	N/A	X Walk 2 Width (in)	N/A
	X Walk 1 Slope (%)	2.1		X Walk 2 Slope (%)	0.8
	X Walk 1 X Slope (%)	1.2		X Walk 2 X Slope (%)	4.2

N/A	Ramp inside XWalk1?	N/A	N/A	Ramp inside XWalk2?	N/A
	Road Slope (%)	0.9	N/A	Clear Space?	N/A
	Road X Slope (%)	4.8	N/A	Clear Space to XWalk (in)	N/A
N/A	Any Obstructions?	N/A	N/A	Storm Grate/Utility Hazard?	N/A
	Obstruction Type			Storm Grate/Utility Type	
		N/A			N/A
			Yes	Surface Condition? (G/P)	Good

Possible Solutions:

Remove & Replace Curb Ramp With Two New Directional Ramps or Equivalent.

R304.2.2

Total Cost: \$ 3200.00
