# Access Compliance Report

## Public Rights-of-Way

### (Curb Ramps)

| Intersection ID: 27192 | Main Street: MCKEE_RD | Cross Street: TILLEY_MORRIS_RD | Location: SE |

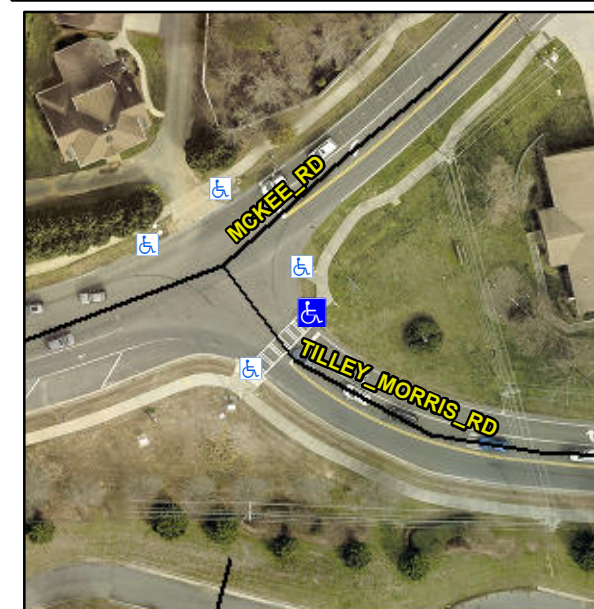
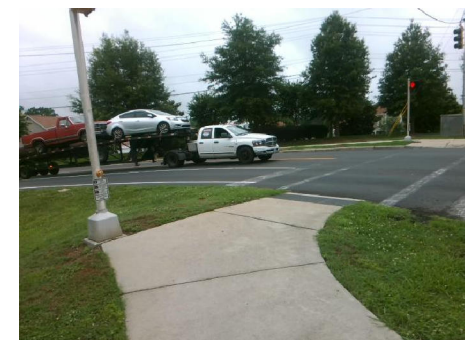
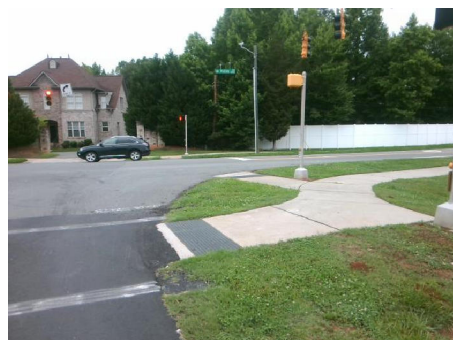
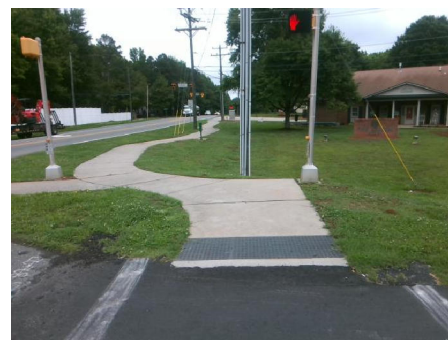
| ADA ID: 65DF08809417 | Ramp Type: BlendTrans1 | Initial Pass/Fail: Pass | Overall Compliance: No |

**NO CURB**

| Compliance | Description | Data | Compliance | Description | Data |
|---|---|---|---|---|---|
| No | Landing X Slope (%) | 3.3 | Yes | DWS Full Width? | Yes |

**Remove & Replace Landing.**

**R304.5.3**

\$ 500.00
