# Access Compliance Report

## Public Rights-of-Way

### (Curb Ramps)

Intersection ID: 48615	Main Street: HARRIS_STATION_BV	Cross Street: ROCKY_RIVER_RD	Location: SW
ADA ID: 65E0AB70C530	Ramp Type: Perpendicular	Initial Pass/Fail: Fail	Overall Compliance: No
Codes/Mitigation Info/Possible Solution		Field Measurements/Component Compliance	
Severity Score: 21.25

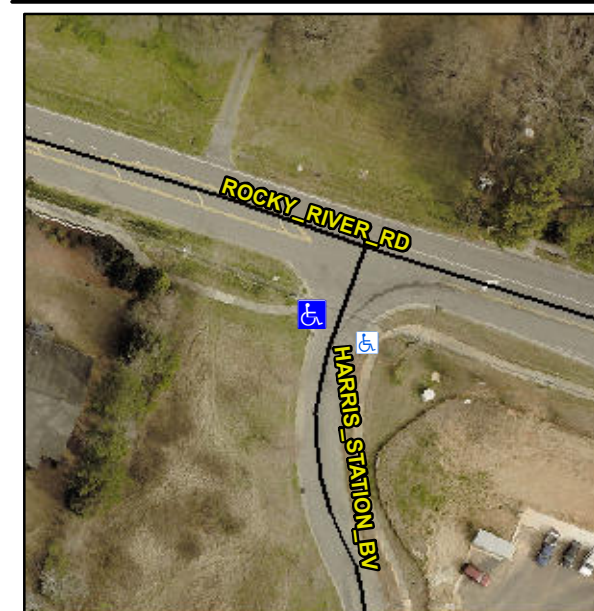
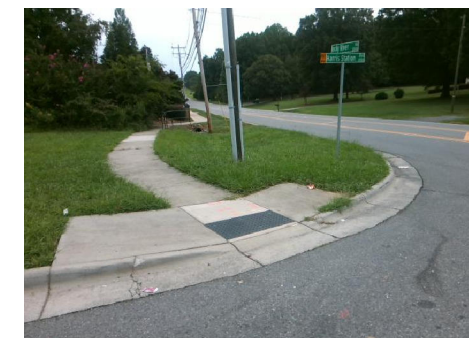
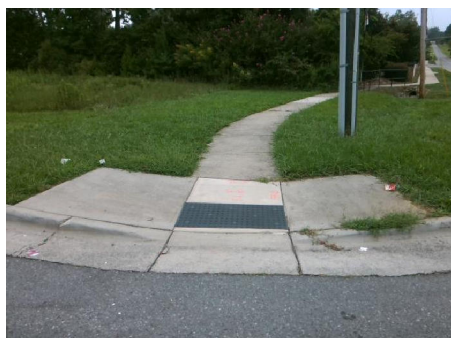
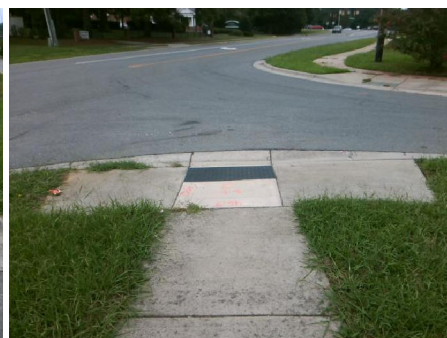
**Not Found, R304.5.1, R304.5.3**

Compliance	Description	Data	Compliance	Description	Data
N/A	Ramp Length (in)	59.0	Yes	Ramp Slope (%)	5.1
No	Ramp Width (in)	46.5	No	Ramp XSlope (%)	6.6
N/A	Flare Type LT	N/A	N/A	Flare Type RT	N/A
N/A	Flare Slope LT (%)	N/A	N/A	Flare Slope RT (%)	N/A
N/A	Flare Traversable LT?	N/A	N/A	Flare Traversable RT?	N/A
N/A	Landing Length (in)	N/A	N/A	DWS Provided?	N/A
N/A	Landing Width (in)	N/A	N/A	DWS Contrast?	N/A
N/A	Landing Slope (%)	N/A	N/A	DWS Length (in)	N/A
N/A	Landing X Slope (%)	N/A	N/A	DWS Full Width?	N/A
N/A	Landing Curb? (Y/N)	N/A	N/A	DWS Offset (in)	N/A
N/A	Shared Landing?	N/A			
N/A	Gutter Ponding?	N/A	N/A	Gutter Slope (%)	N/A
N/A	Gutter Lip Ht (in)	N/A	N/A	Gutter X Slope (%)	N/A
N/A	Painted X Walk1?	No	N/A	Painted X Walk2?	N/A
	X Walk 1 Direction	To SE		X Walk 2 Direction	N/A
N/A	X Walk 1 Width (in)	N/A	N/A	X Walk 2 Width (in)	N/A
	X Walk 1 Slope (%)	3.0		X Walk 2 Slope (%)	N/A
	X Walk 1 X Slope (%)	2.8		X Walk 2 X Slope (%)	N/A

N/A	Ramp inside XWalk1?	N/A	N/A	Ramp inside XWalk2?	N/A
	Road Slope (%)	N/A	N/A	Clear Space?	N/A
	Road X Slope (%)	N/A	N/A	Clear Space to XWalk (in)	N/A
N/A	Any Obstructions?	N/A	N/A	Storm Grate/Utility Hazard?	N/A
	Obstruction Type			Storm Grate/Utility Type	
		N/A			N/A
			Yes	Surface Condition? (G/P)	Good

**Remove & Replace Entire Ramp.**

Total Cost: \$ 1850.00
