Access Compliance Report

Public Rights-of-Way

(Curb Ramps)

Intersection ID: 9459	Main Street: EASTWAY_DR	Cross Street: HOWIE_CR	Location: NW
ADA ID: 65E50789E266	Ramp Type: Perpendicular	Initial Pass/Fail: Fail	Overall Compliance: No
			Severity Score: 13.75

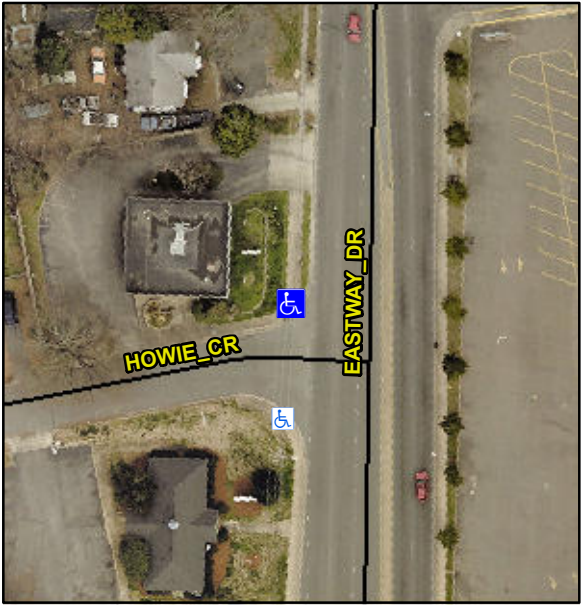
Possible Solutions:		Compliance	Description	Data
	Remove & Replace Entire Ramp.		No	Ramp Length (in)	79.5
			Yes	Ramp Width (in)	48.0
			N/A	Flare Type LT	N/A
			N/A	Flare Slope LT (%)	N/A
			N/A	Flare Traversable LT?	N/A
			N/A	Landing Length (in)	N/A
			N/A	Landing Width (in)	N/A
			N/A	Landing Slope (%)	N/A
			N/A	Landing X Slope (%)	N/A
<p>Surveyor Notes:</p> <p>N/A</p> <p>PROW/ADA:</p> <p>R304.2.2, R304.5.3</p>			N/A	Flare Type RT	N/A
			N/A	Flare Slope RT (%)	N/A
			N/A	Flare Traversable RT?	N/A
			N/A	DWS Provided?	N/A
			N/A	DWS Contrast?	N/A
			N/A	DWS Length (in)	N/A
			N/A	DWS Full Width?	N/A
			N/A	DWS Offset (in)	N/A
			N/A	Gutter Ponding?	N/A
			N/A	Gutter Lip Ht (in)	1.0
<p>Total Cost:</p> <p>\$ 1850.00</p>			No	Painted X Walk2?	N/A
			No	X Walk 2 Direction	N/A
			N/A	X Walk 2 Width (in)	N/A

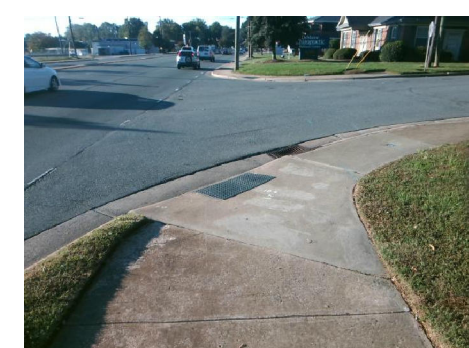
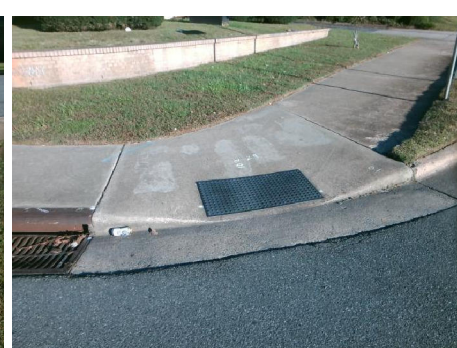
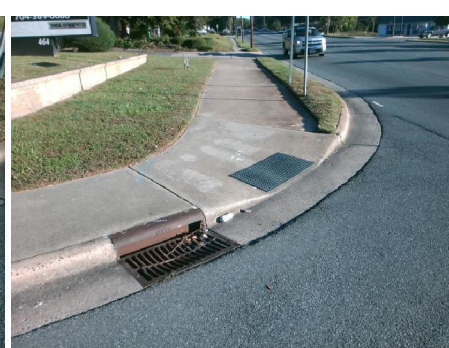
0.1	X Walk 2 Slope (%)	N/A
			1.5	X Walk 2 X Slope (%)	N/A
			N/A	Ramp inside XWalk2?	N/A
			N/A	Clear Space?	N/A
			N/A	Clear Space to XWalk (in)	N/A
			N/A	Storm Grate/Utility Hazard?	N/A
			N/A	Storm Grate/Utility Type	N/A
<p>Obstruction Type</p>			N/A		N/A
			Yes	Surface Condition? (G/P)	Good
