Access Compliance Report

Public Rights-of-Way

(Curb Ramps)

Intersection ID: 46687	Main Street: AYERS_ORCHARD_WY	Cross Street: TROTTERS_RIDGE_RD	Location: NE
ADA ID: 65ECC03BF89F	Ramp Type: Perpendicular	Initial Pass/Fail: Fail	Overall Compliance: No
			Severity Score: 21.25

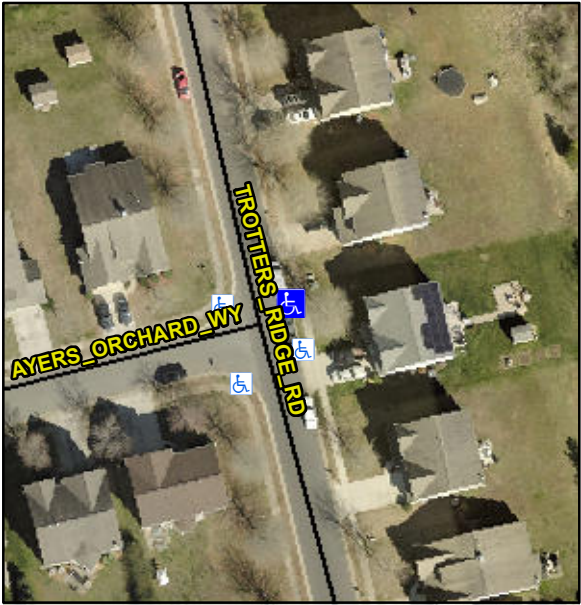
Possible Solutions:		Compliance	Description	Data	
	Remove & Replace Entire Ramp.		N/A	Ramp Length (in)	48.0	No
			No	Ramp Width (in)	46.0	Yes
			N/A	Flare Type LT	N/A	N/A
			N/A	Flare Slope LT (%)	N/A	N/A
			N/A	Flare Traversable LT?	N/A	N/A
			N/A	Landing Length (in)	N/A	N/A
			N/A	Landing Width (in)	N/A	N/A
			N/A	Landing Slope (%)	N/A	N/A
			N/A	Landing X Slope (%)	N/A	N/A
<p>Surveyor Notes:</p> <p>N/A</p> <p>PROW/ADA:</p> <p>Not Found, R304.5.1, R304.2.2</p>			N/A	Landing Curb? (Y/N)	N/A	N/A
			N/A	Shared Landing?	N/A	
			N/A	Gutter Ponding?	N/A	N/A
			N/A	Gutter Lip Ht (in)	N/A	N/A
			N/A	Painted X Walk1?	No	N/A
				X Walk 1 Direction	To W	
			N/A	X Walk 1 Width (in)	N/A	N/A
				X Walk 1 Slope (%)	1.7	
				X Walk 1 X Slope (%)	1.3	
			N/A	Ramp inside XWalk1?	N/A	N/A
<p>Street 1 Name</p> <p>Stop Condition-Street 2</p> <p>Street 2 Name</p> <p>Stop Condition-Street 1</p>			N/A	Road Slope (%)	N/A	N/A

Road X Slope (%)	N/A	N/A
			N/A	Any Obstructions?	N/A	N/A
				Obstruction Type		
					N/A	N/A
			Yes	Surface Condition? (G/P)	Good	
Total Cost:		\$ 1850.00
