# Access Compliance Report

## Public Rights-of-Way

### (Curb Ramps)

Intersection ID: 10862	Main Street: N_GRAHAM_ST	Cross Street: DALTON_AV	Location:	SW
ADA ID: 65EF5C731E02	Ramp Type: Perpendicular	Initial Pass/Fail: Fail	Overall Compliance: No	Severity Score: 60

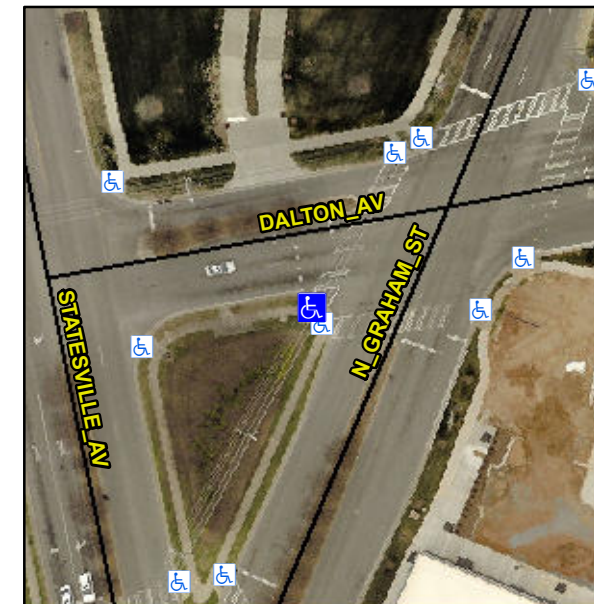
**Not Found, R304.5.1, R304.5.3**

Compliance	Description	Data	Compliance	Description	Data
N/A	Ramp Length (in)	60.0	Yes	Ramp Slope (%)	7.3
No	Ramp Width (in)	31.5	No	Ramp XSlope (%)	7.9
N/A	Flare Type LT	N/A	N/A	Flare Type RT	N/A
N/A	Flare Slope LT (%)	N/A	N/A	Flare Slope RT (%)	N/A
N/A	Flare Traversable LT?	N/A	N/A	Flare Traversable RT?	N/A
N/A	Landing Length (in)	N/A	N/A	DWS Provided?	N/A
N/A	Landing Width (in)	N/A	N/A	DWS Contrast?	N/A
N/A	Landing Slope (%)	N/A	N/A	DWS Length (in)	N/A
N/A	Landing X Slope (%)	N/A	N/A	DWS Full Width?	N/A
N/A	Landing Curb? (Y/N)	N/A	N/A	DWS Offset (in)	N/A
N/A	Shared Landing?	N/A			
N/A	Gutter Ponding?	N/A	N/A	Gutter Slope (%)	N/A
N/A	Gutter Lip Ht (in)	N/A	N/A	Gutter X Slope (%)	N/A
N/A	Painted X Walk1?	Yes	N/A	Painted X Walk2?	N/A
	X Walk 1 Direction	To NE		X Walk 2 Direction	N/A
N/A	X Walk 1 Width (in)	119.0	N/A	X Walk 2 Width (in)	N/A
	X Walk 1 Slope (%)	2.7		X Walk 2 Slope (%)	N/A
	X Walk 1 X Slope (%)	5.2		X Walk 2 X Slope (%)	N/A

N/A	Ramp inside XWalk1?	Yes	N/A	Ramp inside XWalk2?	N/A
	Road Slope (%)	N/A	N/A	Clear Space?	N/A
	Road X Slope (%)	N/A	N/A	Clear Space to XWalk (in)	N/A
N/A	Any Obstructions?	N/A	N/A	Storm Grate/Utility Hazard?	N/A
	Obstruction Type			Storm Grate/Utility Type	
		N/A			N/A
			Yes	Surface Condition? (G/P)	Good

**Remove & Replace Entire Ramp.**

Total Cost: \$ 1850.00
