Access Compliance Report

Public Rights-of-Way

(Curb Ramps)

Intersection ID: 32143	Main Street: NEVERMORE_WY	Cross Street: POE_CT	Location: SE
ADA ID: 65F97394C1CA	Ramp Type: Perpendicular Diagonal	Initial Pass/Fail: Fail	Overall Compliance: No
		Severity Score: 10

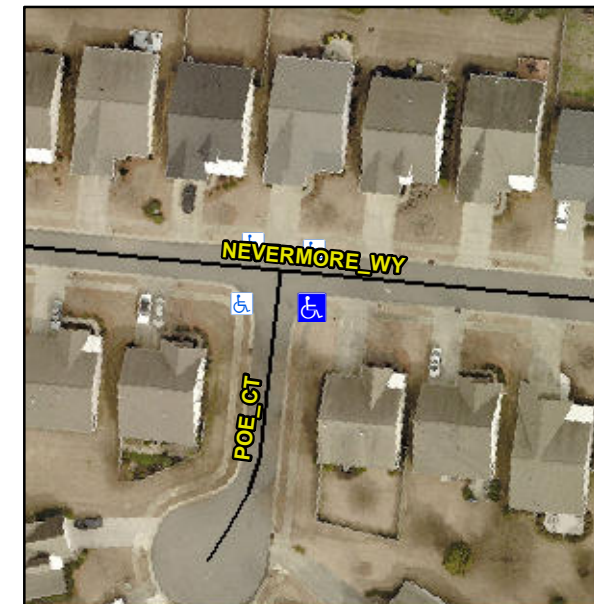
Not Found, R304.5.1, R304.5.3

Compliance	Description	Data	Compliance	Description	Data
N/A	Ramp Length (in)	47.0	Yes	Ramp Slope (%)	5.6
No	Ramp Width (in)	38.0	No	Ramp XSlope (%)	2.5
N/A	Flare Type LT	N/A	N/A	Flare Type RT	N/A
N/A	Flare Slope LT (%)	N/A	N/A	Flare Slope RT (%)	N/A
N/A	Flare Traversable LT?	N/A	N/A	Flare Traversable RT?	N/A
N/A	Landing Length (in)	N/A	N/A	DWS Provided?	N/A
N/A	Landing Width (in)	N/A	N/A	DWS Contrast?	N/A
N/A	Landing Slope (%)	N/A	N/A	DWS Length (in)	N/A
N/A	Landing X Slope (%)	N/A	N/A	DWS Full Width?	N/A
N/A	Landing Curb? (Y/N)	N/A	N/A	DWS Offset (in)	N/A
N/A	Shared Landing?	N/A			
N/A	Gutter Ponding?	N/A	N/A	Gutter Slope (%)	N/A
N/A	Gutter Lip Ht (in)	N/A	N/A	Gutter X Slope (%)	N/A
N/A	Painted X Walk1?	No	N/A	Painted X Walk2?	No
	X Walk 1 Direction	To NE		X Walk 2 Direction	To NW
N/A	X Walk 1 Width (in)	N/A	N/A	X Walk 2 Width (in)	N/A
	X Walk 1 Slope (%)	3.0		X Walk 2 Slope (%)	2.4
	X Walk 1 X Slope (%)	0.1		X Walk 2 X Slope (%)	1.6

N/A	Ramp inside XWalk1?	N/A	N/A	Ramp inside XWalk2?	N/A
	Road Slope (%)	0.6	N/A	Clear Space?	N/A
	Road X Slope (%)	4.4	N/A	Clear Space to XWalk (in)	N/A
N/A	Any Obstructions?	N/A	N/A	Storm Grate/Utility Hazard?	N/A
	Obstruction Type			Storm Grate/Utility Type	
		N/A			N/A
			Yes	Surface Condition? (G/P)	Good

Remove & Replace Curb Ramp With Two New Directional Ramps or Equivalent.
