Access Compliance Report

Public Rights-of-Way (Curb Ramps)

Intersection ID: 49655	Main Street: GREENWAY_CRESCENT_LN	Cross Street: SEIGLE_POINT_DR	Location:	N
ADA ID: 660924F1B79C	Ramp Type: Directional1	Initial Pass/Fail: Fail	Overall Compliance: No	Severity Score: 1.25
Codes/Mitigation Info/Possible Solution		Field Measurements/Component Compliance

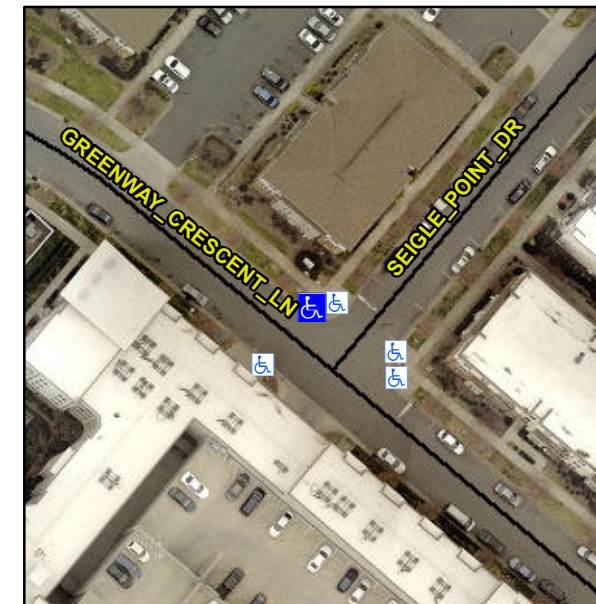
R304.5.3

Compliance	Description	Data	Compliance	Description	Data
N/A	Ramp Length (in)	81.0	N/A	Grade Break?	N/A
Yes	Ramp Width (in)	73.0	N/A	Grade Break Slope (%)	0.0
Yes	Ramp Slope (%)	7.2	N/A	Grade Break XSlope (%)	0.0
No	Ramp XSlope (%)	2.6			
N/A	Flare Type LT	N/A	N/A	Flare Type RT	N/A
N/A	Flare Slope LT (%)	N/A	N/A	Flare Slope RT (%)	0.0
N/A	Flare Traversable LT?	N/A	N/A	Flare Traversable RT?	N/A
N/A	Landing Length (in)	0.0	N/A	DWS Provided?	N/A
N/A	Landing Width (in)	0.0	N/A	DWS Contrast?	N/A
N/A	Landing Slope (%)	0.0	N/A	DWS Length (in)	N/A
N/A	Landing X Slope (%)	0.0	N/A	DWS Full Width?	N/A
N/A	Landing Curb? (Y/N)	N/A	N/A	DWS Offset LT (in)	N/A
N/A	Shared Landing?	N/A	N/A	DWS Offset RT (in)	N/A
N/A	Gutter Ponding?	0.0	N/A	Gutter Slope (%)	N/A
N/A	Gutter Lip Ht (in)	0.0	N/A	Gutter X Slope (%)	N/A
N/A	Painted X Walk1?	No		Road Slope (%)	0.7
	X Walk 1 Direction	To SW		Road X Slope (%)	4.1
	X Walk 1 Width (in)	N/A		Clear Space?	N/A

X Walk 1 Slope (%)	0.7	N/A	Clear Space to XWalk (in)	N/A
	X Walk 1 X Slope (%)	4.1	N/A	Storm Grate/Utility Hazard?	N/A
N/A	Ramp inside XWalk1?	N/A		Storm Grate/Utility Type	
N/A	Any Obstructions?	N/A			N/A
	Obstruction Type		Yes	Surface Condition? (G/P)	Good
			N/A	Curb Slope (%)	2.5

Remove & Replace Entire Ramp.
