# Access Compliance Report

## Public Rights-of-Way

### (Curb Ramps)

| Intersection ID: 12925 | Main Street: S_CHURCH_ST | Cross Street: W_CARSON_BV | Location: NE |

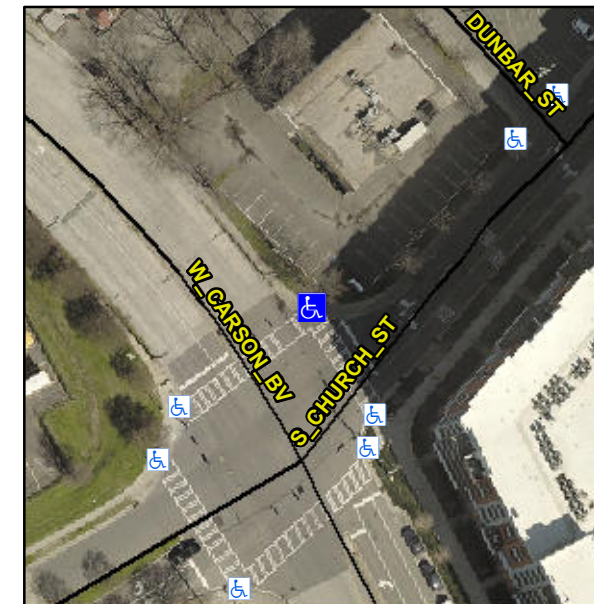
| ADA ID: 6622F9E85CA0 | Ramp Type: PerpDiag | Initial Pass/Fail: Fail | Overall Compliance: No |

**R304.2.2, R304.5.3**

| Compliance | Description | Data | Compliance | Description | Data |
|---|---|---|---|---|---|
| N/A | Ramp Length (in) | 64.0 | No | Ramp Slope (%) | 10.1 |
| Yes | Ramp Width (in) | 48.0 | No | Ramp XSlope (%) | 5.3 |

**Remove & Replace Curb Ramp With Two New Directional Ramps or Equivalent.**

Total Cost: \$ 3200.00
