Access Compliance Report Public Rights-of-Way (Curb Ramps)

Intersection ID: 10037315 Main Street: SARDIS_RD Cross Street: N/A Location: SE

ADA ID: 6638596965DA Ramp Type: PerpDiag Initial Pass/Fail: Fail Overall Compliance: No Severity Score: 13.75

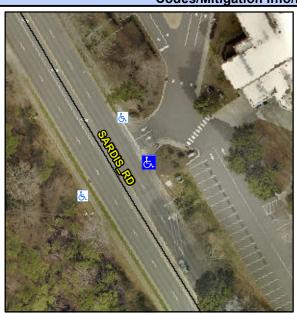
Not Found, R304.2.2, R304.5.3

Comp	liance Description	Data	Comp	liance	Description	Data
N/A	Ramp Length (in)	58.5	No	Ram	Slope (%)	10.1
Yes	Ramp Width (in)	49.0	No	Ram	XSlope (%)	4.2
N/A	Flare Type LT	N/A	N/A	Flare	Type RT	N/A
N/A	Flare Slope LT (%)	N/A	N/A	Flare	Slope RT (%)	N/A
N/A	Flare Traversable LT?	N/A	N/A	Flare	Traversable RT?	N/A
N/A	Landing Length (in)	N/A	N/A	DWS	Provided?	N/A
N/A	Landing Width (in)	N/A	N/A	DWS	Contrast?	N/A
N/A	Landing Slope (%)	N/A	N/A	DWS	Length (in)	N/A
N/A	Landing X Slope (%)	N/A	N/A	DWS	Full Width?	N/A
N/A	Landing Curb? (Y/N)	N/A	N/A	DWS	Offset (in)	N/A
N/A	Shared Landing?	N/A				
N/A	Gutter Ponding?	N/A	N/A	Gutte	er Slope (%)	N/A
N/A	Gutter Lip Ht (in)	N/A	N/A	Gutte	er X Slope (%)	N/A
N/A	Painted X Walk1?	No	N/A	Paint	ed X Walk2?	No
	X Walk 1 Direction	To N		X Wa	lk 2 Direction	To W
N/A	X Walk 1 Width (in)	N/A	N/A	X Wa	lk 2 Width (in)	N/A
	X Walk 1 Slope (%)	7.4		X Wa	lk 2 Slope (%)	0.0
	X Walk 1 X Slope (%)	1.7		X Wa	lk 2 X Slope (%)	4.3

Remove & Replace Curb Ramp With Two New Directional Ramps or Equivalent.
