Access Compliance Report Public Rights-of-Way (Curb Ramps)

Intersection ID: 18350 Main Street: PROVIDENCE_RD Cross Street: SHARON_LN Location: E

ADA ID: 66405FE38484 Ramp Type: BlendTrans1 Initial Pass/Fail: Fail Overall Compliance: No Severity Score: 10

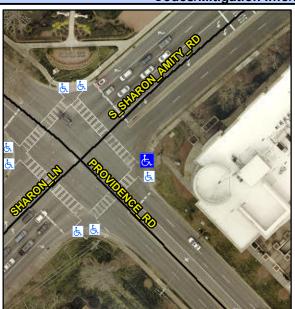
Not Found, R304.5.1, R304.5.3

Field Measurements/Component Compliance						
	liance Description	Data			Description	Data
N/A	Ramp Length (in)	59.0	Yes		Trans Slope (%)	1.7
No	Ramp Width (in)	45.5	No	Blend	Trans XSlope (%)	2.6
N/A	Flare Type LT	N/A	N/A	Flare	Type RT	N/A
N/A	Flare Slope LT (%)	N/A	N/A	Flare	Slope RT (%)	N/A
N/A	Flare Traversable LT?	N/A	N/A	Flare	Traversable RT?	N/A
N/A	Landing Length (in)	N/A	N/A	DWS	Provided?	N/A
N/A	Landing Width (in)	N/A	N/A	DWS	Contrast?	N/A
N/A	Landing Slope (%)	N/A	N/A	DWS	Length (in)	N/A
N/A	Landing X Slope (%)	N/A	N/A	DWS	Full Width?	N/A
N/A	Landing Curb? (Y/N)	N/A	N/A	DWS	Offset (in)	N/A
N/A	Shared Landing?	N/A				
N/A	Gutter Ponding?	N/A	N/A	Gutte	r Slope (%)	N/A
N/A	Gutter Lip Ht (in)	N/A	N/A	Gutte	r X Slope (%)	N/A
N/A	Painted X Walk1?	Yes	N/A	Paint	ed X Walk2?	N/A
	X Walk 1 Direction	To SW		X Wa	lk 2 Direction	N/A
	X Walk 1 Width (in)	105.0		X Wa	lk 2 Width (in)	N/A
	X Walk 1 Slope (%)	1.8		X Wa	lk 2 Slope (%)	N/A

X Walk 1 X Slope (%)	1.3		X Wa	lk 2 X Slope (%)	N/A
N/A	Ramp inside XWalk1?	No	N/A	Ramp	inside XWalk2?	N/A
	Road Slope (%)	1.3		Clear	Space?	N/A
	Road X Slope (%)	1.8	N/A	Clear	Space to XWalk (in)	N/A
N/A	Any Obstructions?	N/A	N/A	Storm	n Grate/Utility Hazard?	N/A
	Obstruction Type			Storm	n Grate/Utility Type

• •	N/A				N/A
			Yes	Surfa	ce Condition? (G/P)	Good
			No		Slope (%)	11.6
4					,

Remove & Replace Curb Ramp With Two New Directional Ramps or Equivalent. Restripe Crosswalk.
