Access Compliance Report

Public Rights-of-Way

(Curb Ramps)

Intersection ID: 48474	Main Street: AUTUMN_OAK_DR	Cross Street: WONDERING_OAK_LN	Location: NW
ADA ID: 6641B9DA1059	Ramp Type: PerpDiag	Initial Pass/Fail: Fail	Overall Compliance: No
Codes/Mitigation Info/Possible Solution			Severity Score: 35
			Field Measurements/Component Compliance

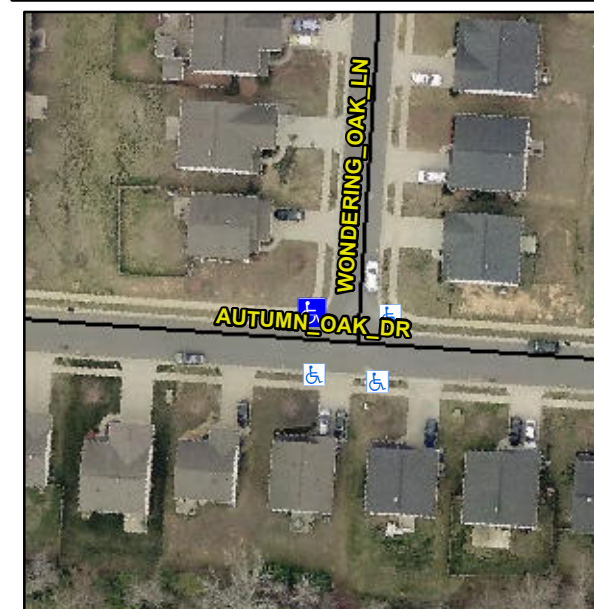
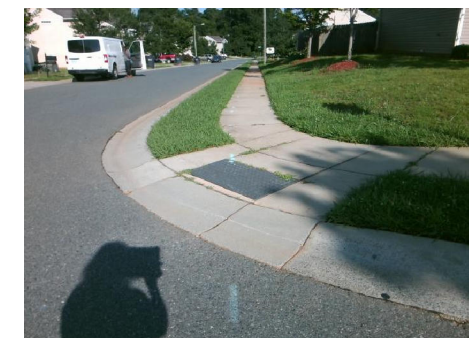
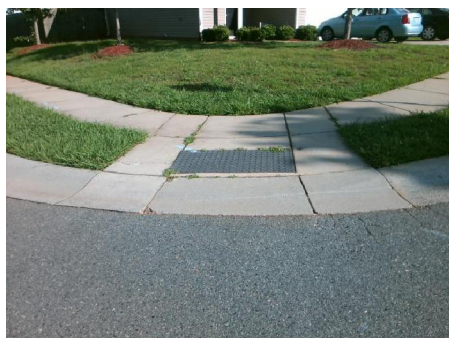
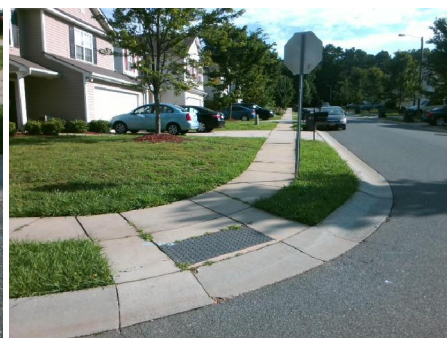
Not Found, R304.5.1, R304.2.2, R304.5.3

Compliance	Description	Data	Compliance	Description	Data
N/A	Ramp Length (in)	47.5	No	Ramp Slope (%)	14.8
No	Ramp Width (in)	46.5	No	Ramp XSlope (%)	4.5
N/A	Flare Type LT	N/A	N/A	Flare Type RT	N/A
N/A	Flare Slope LT (%)	N/A	N/A	Flare Slope RT (%)	N/A
N/A	Flare Traversable LT?	N/A	N/A	Flare Traversable RT?	N/A
N/A	Landing Length (in)	N/A	N/A	DWS Provided?	N/A
N/A	Landing Width (in)	N/A	N/A	DWS Contrast?	N/A
N/A	Landing Slope (%)	N/A	N/A	DWS Length (in)	N/A
N/A	Landing X Slope (%)	N/A	N/A	DWS Full Width?	N/A
N/A	Landing Curb? (Y/N)	N/A	N/A	DWS Offset (in)	N/A
N/A	Shared Landing?	N/A			
N/A	Gutter Ponding?	N/A	N/A	Gutter Slope (%)	N/A
N/A	Gutter Lip Ht (in)	N/A	N/A	Gutter X Slope (%)	N/A
N/A	Painted X Walk1?	No	N/A	Painted X Walk2?	No
	X Walk 1 Direction	To S		X Walk 2 Direction	To E
N/A	X Walk 1 Width (in)	N/A	N/A	X Walk 2 Width (in)	N/A
	X Walk 1 Slope (%)	0.2		X Walk 2 Slope (%)	2.8
	X Walk 1 X Slope (%)	2.5		X Walk 2 X Slope (%)	2.2

N/A	Ramp inside XWalk1?	N/A	N/A	Ramp inside XWalk2?	N/A
	Road Slope (%)	2.7	N/A	Clear Space?	N/A
	Road X Slope (%)	0.5	N/A	Clear Space to XWalk (in)	N/A
N/A	Any Obstructions?	N/A	N/A	Storm Grate/Utility Hazard?	N/A
	Obstruction Type			Storm Grate/Utility Type	
		N/A			N/A
			Yes	Surface Condition? (G/P)	Good

Remove & Replace Curb Ramp With Two New Directional Ramps or Equivalent.
