Access Compliance Report

Public Rights-of-Way

(Curb Ramps)

| Intersection ID: 17676 | Main Street: N_SHARON_AMITY_RD | Cross Street: WINDEMERE_LN | Location: NE |

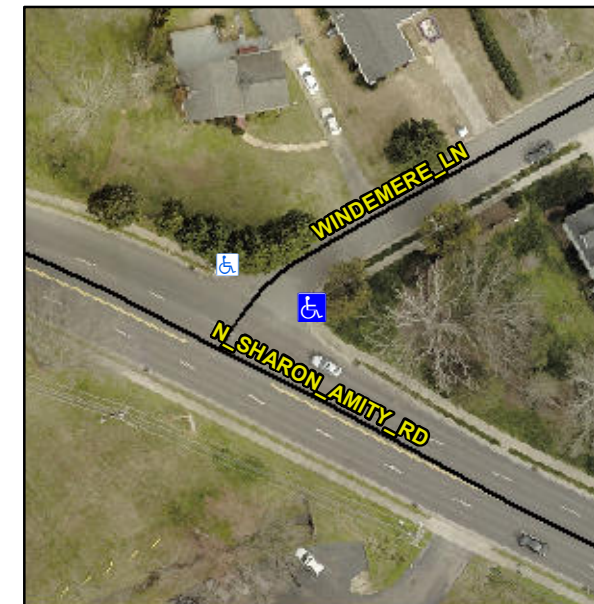
Not Found, R304.5.1, R304.2.2, R304.5.3

| Compliance | Description | Data | Compliance | Description | Data |
|---|---|---|---|---|---|
| N/A | Ramp Length (in) | 63.0 | No | Ramp Slope (%) | 10.0 |
| No | Ramp Width (in) | 30.0 | No | Ramp XSlope (%) | 11.3 |

Remove & Replace Curb Ramp With Two New Directional Ramps or Equivalent.

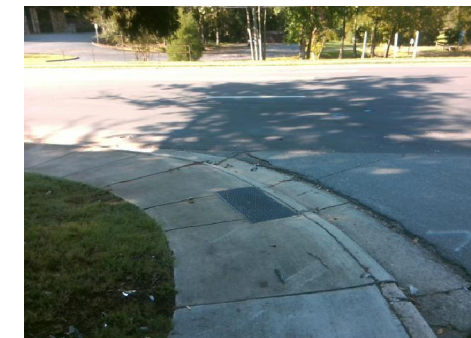
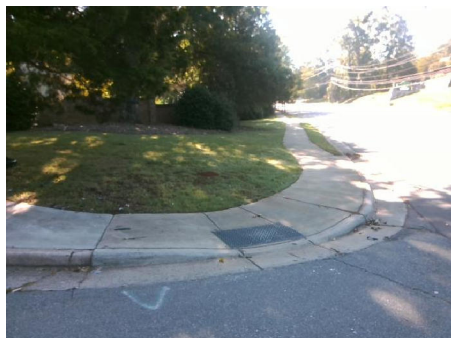
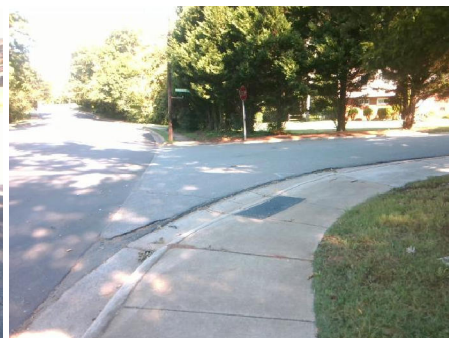
| ADA ID: 664689FE0E66 | Ramp Type: PerpDiag | Initial Pass/Fail: Fail | Overall Compliance: No |
