# Access Compliance Report

## Public Rights-of-Way

### (Curb Ramps)

Intersection ID: 12244	Main Street: BELMONT_AV	Cross Street: HARRILL_ST	Location: S
ADA ID: 6647DE6513BF	Ramp Type: BlendTrans1	Initial Pass/Fail: Fail	Overall Compliance: No
		Severity Score: 10

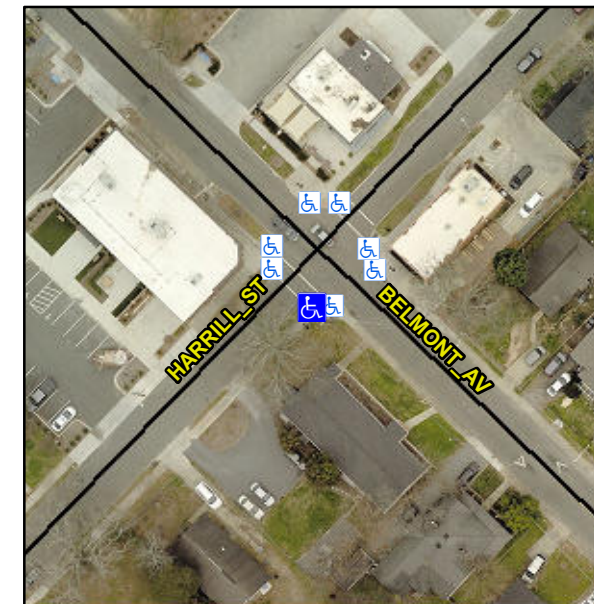
**Not Found, R304.5.1, R304.5.3**

Compliance	Description	Data	Compliance	Description	Data
N/A	Ramp Length (in)	51.5	Yes	BlendTrans Slope (%)	3.5
No	Ramp Width (in)	47.0	No	BlendTrans XSlope (%)	3.7
N/A	Flare Type LT	N/A	N/A	Flare Type RT	N/A
N/A	Flare Slope LT (%)	N/A	N/A	Flare Slope RT (%)	N/A
N/A	Flare Traversable LT?	N/A	N/A	Flare Traversable RT?	N/A
N/A	Landing Length (in)	N/A	N/A	DWS Provided?	N/A
N/A	Landing Width (in)	N/A	N/A	DWS Contrast?	N/A
N/A	Landing Slope (%)	N/A	N/A	DWS Length (in)	N/A
N/A	Landing X Slope (%)	N/A	N/A	DWS Full Width?	N/A
N/A	Landing Curb? (Y/N)	N/A	N/A	DWS Offset (in)	N/A
N/A	Shared Landing?	N/A			
N/A	Gutter Ponding?	N/A	N/A	Gutter Slope (%)	N/A
N/A	Gutter Lip Ht (in)	N/A	N/A	Gutter X Slope (%)	N/A
N/A	Painted X Walk1?	Yes	N/A	Painted X Walk2?	N/A
	X Walk 1 Direction	To NW		X Walk 2 Direction	N/A
	X Walk 1 Width (in)	96.0		X Walk 2 Width (in)	N/A
	X Walk 1 Slope (%)	1.7		X Walk 2 Slope (%)	N/A
	X Walk 1 X Slope (%)	3.2		X Walk 2 X Slope (%)	N/A

N/A	Ramp inside XWalk1?	Yes	N/A	Ramp inside XWalk2?	N/A
	Road Slope (%)	3.2		Clear Space?	N/A
	Road X Slope (%)	1.7	N/A	Clear Space to XWalk (in)	N/A
N/A	Any Obstructions?	N/A	N/A	Storm Grate/Utility Hazard?	N/A
	Obstruction Type			Storm Grate/Utility Type	
		N/A			N/A
			Yes	Surface Condition? (G/P)	Good
			No	Curb Slope (%)	5.1

**Remove & Replace Curb Ramp With Two New Directional Ramps or Equivalent.**
