Access Compliance Report

Public Rights-of-Way

(Curb Ramps)

Intersection ID: 8599	Main Street: HATERAS_AV	Cross Street: IRMA_ST	Location: NW
ADA ID: 6649AA5A3A51	Ramp Type: PerpDiag	Initial Pass/Fail: Pass	Overall Compliance: No
Codes/Mitigation Info/Possible Solution		Field Measurements/Component Compliance

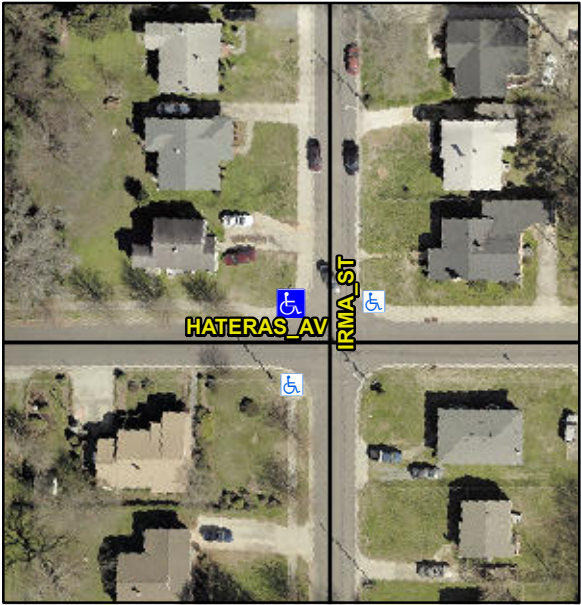
Possible Solutions:	Compliance	Description	Data	Compliance	Description	Data
	Remove & Replace Curb Ramp With Two New Directional Ramps or Equivalent.	N/A	Ramp Length (in)	72.0	Yes	Ramp Slope (%)	7.4
<p>Surveyor Notes:</p> <p>N/A</p> <p>PROW/ADA:</p> <p>Not Found, R304.2.1, R304.2.2-Perp, R304.3.2-Para, R304.5.3, R305.2</p>		Yes	Ramp Width (in)	48.0	Yes	Ramp XSlope (%)	0.9
		N/A	Flare Type LT	Sloped	N/A	Flare Type RT	N/A
		N/A	Flare Slope LT (%)	8.6	Yes	Flare Slope RT (%)	6.5
		N/A	Flare Traversable LT?	Yes	N/A	Flare Traversable RT?	Yes
		No	Landing Length (in)	N/A	Yes	DWS Provided?	Yes
		No	Landing Width (in)	N/A	Yes	DWS Contrast?	Yes
		No	Landing Slope (%)	N/A	Yes	DWS Length (in)	25.0
		No	Landing X Slope (%)	N/A	Yes	DWS Full Width?	Yes
		N/A	Landing Curb? (Y/N)	No	No	DWS Offset (in)	5.0
		N/A	Shared Landing?	N/A			
		Yes	Gutter Ponding?	No	Yes	Gutter Slope (%)	0.4
		Yes	Gutter Lip Ht (in)	0.0	Yes	Gutter X Slope (%)	1.7

N/A	Painted X Walk1?	No	N/A	Painted X Walk2?	No
			X Walk 1 Direction	To S		X Walk 2 Direction	To E
		N/A	X Walk 1 Width (in)	N/A	N/A	X Walk 2 Width (in)	N/A
			X Walk 1 Slope (%)	3.4		X Walk 2 Slope (%)	2.8
			X Walk 1 X Slope (%)	4.0		X Walk 2 X Slope (%)	2.1
		N/A	Ramp inside XWalk1?	N/A	N/A	Ramp inside XWalk2?	N/A
			Road Slope (%)	2.0	N/A	Clear Space?	Yes
			Road X Slope (%)	4.5	N/A	Clear Space to XWalk (in)	N/A
		Yes	Any Obstructions?	No	Yes	Storm Grate/Utility Hazard?	No
			Obstruction Type			Storm Grate/Utility Type	
					N/A		N/A
					Yes	Surface Condition? (G/P)	Good
