# Access Compliance Report

## Public Rights-of-Way

### (Curb Ramps)

| Intersection ID: 10028913 | Main Street: IDLEWILD_RD_NORTH | Cross Street: N/A | Location: SE |

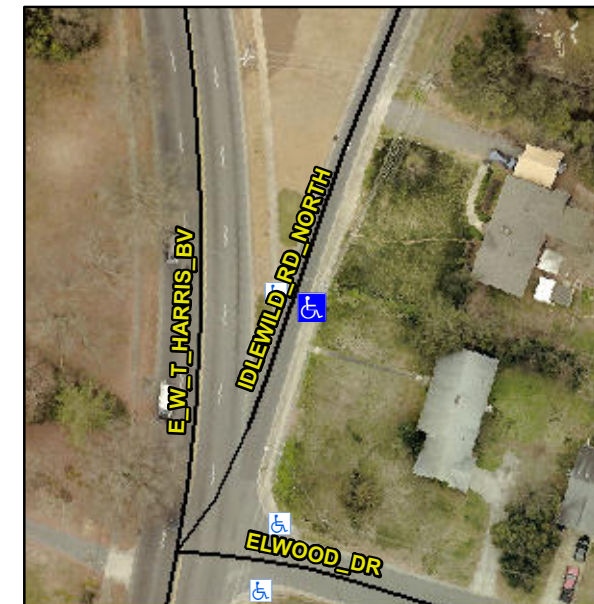
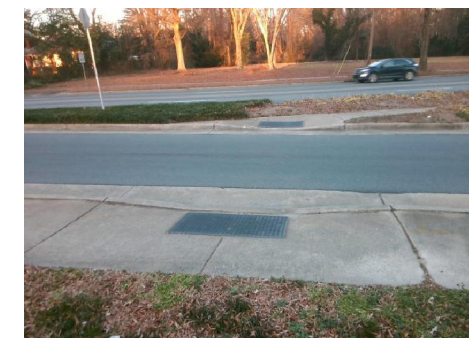
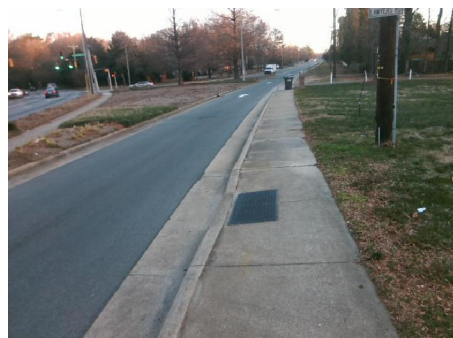
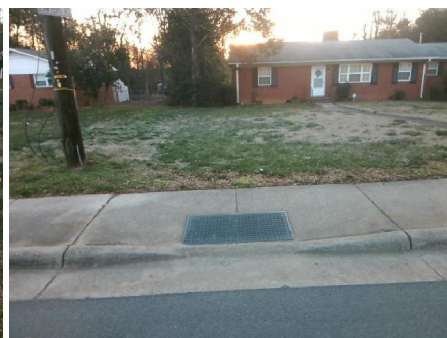
**Not Found, R304.5.1, R304.2.2**

| Compliance | Description | Data | Compliance | Description | Data |
|---|---|---|---|---|---|
| N/A | Ramp Length (in) | 51.0 | No | Ramp Slope (%) | 12.3 |
| No | Ramp Width (in) | 44.0 | Yes | Ramp XSlope (%) | 1.7 |

**Remove & Replace Entire Ramp.**
