# Access Compliance Report

## Public Rights-of-Way

### (Curb Ramps)

Intersection ID: 18365	Main Street: S_TRYON_ST	Cross Street: W_TYVOLA_RD	Location: SE
ADA ID: 664EF574C56E	Ramp Type: Perp	Initial Pass/Fail: Fail	Overall Compliance: No
Severity Score: 12.5			
Codes/Mitigation Info/Possible Solution		Field Measurements/Component Compliance

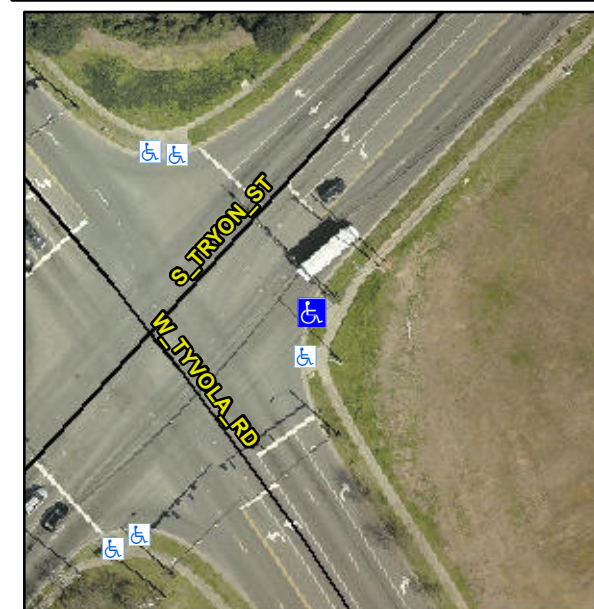
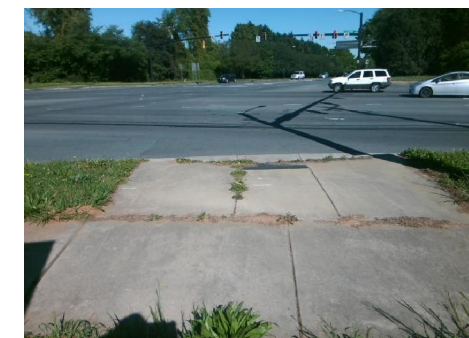
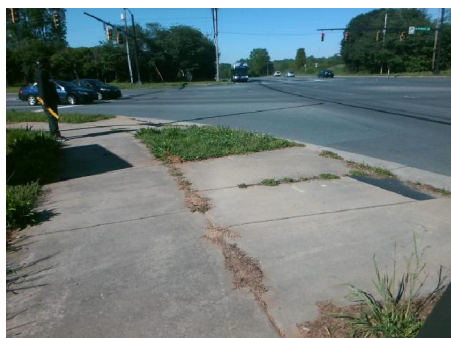
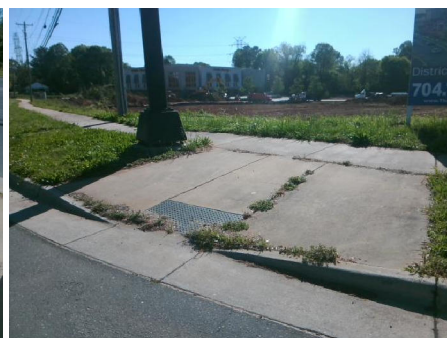
**Not Found, R304.2.2**

Compliance	Description	Data	Compliance	Description	Data
N/A	Ramp Length (in)	122.0	No	Ramp Slope (%)	8.4
Yes	Ramp Width (in)	48.0	Yes	Ramp XSlope (%)	0.5
N/A	Flare Type LT	N/A	N/A	Flare Type RT	N/A
N/A	Flare Slope LT (%)	N/A	N/A	Flare Slope RT (%)	N/A
N/A	Flare Traversable LT?	N/A	N/A	Flare Traversable RT?	N/A
N/A	Landing Length (in)	N/A	N/A	DWS Provided?	N/A
N/A	Landing Width (in)	N/A	N/A	DWS Contrast?	N/A
N/A	Landing Slope (%)	N/A	N/A	DWS Length (in)	N/A
N/A	Landing X Slope (%)	N/A	N/A	DWS Full Width?	N/A
N/A	Landing Curb? (Y/N)	N/A	N/A	DWS Offset (in)	N/A
N/A	Shared Landing?	N/A			
N/A	Gutter Ponding?	N/A	N/A	Gutter Slope (%)	N/A
N/A	Gutter Lip Ht (in)	N/A	N/A	Gutter X Slope (%)	N/A
N/A	Painted X Walk1?	No	N/A	Painted X Walk2?	N/A
	X Walk 1 Direction	To NW		X Walk 2 Direction	N/A
N/A	X Walk 1 Width (in)	N/A	N/A	X Walk 2 Width (in)	N/A
	X Walk 1 Slope (%)	1.7		X Walk 2 Slope (%)	N/A
	X Walk 1 X Slope (%)	1.8		X Walk 2 X Slope (%)	N/A

N/A	Ramp inside XWalk1?	N/A	N/A	Ramp inside XWalk2?	N/A
	Road Slope (%)	N/A	N/A	Clear Space?	N/A
	Road X Slope (%)	N/A	N/A	Clear Space to XWalk (in)	N/A
N/A	Any Obstructions?	N/A	N/A	Storm Grate/Utility Hazard?	N/A
	Obstruction Type			Storm Grate/Utility Type	
		N/A			N/A
			Yes	Surface Condition? (G/P)	Good

Possible Solutions:

**Remove & Replace Entire Ramp.**

Total Cost: \$ 1850.00
