# Access Compliance Report

## Public Rights-of-Way

### (Curb Ramps)

Intersection ID: 25357	Main Street: RAINTREE_LN	Cross Street: WILLOW_POINT_DR	Location: SE
ADA ID: 6651F5229161	Ramp Type: PerpDiag	Initial Pass/Fail: Fail	Overall Compliance: No
		Severity Score: 12.5

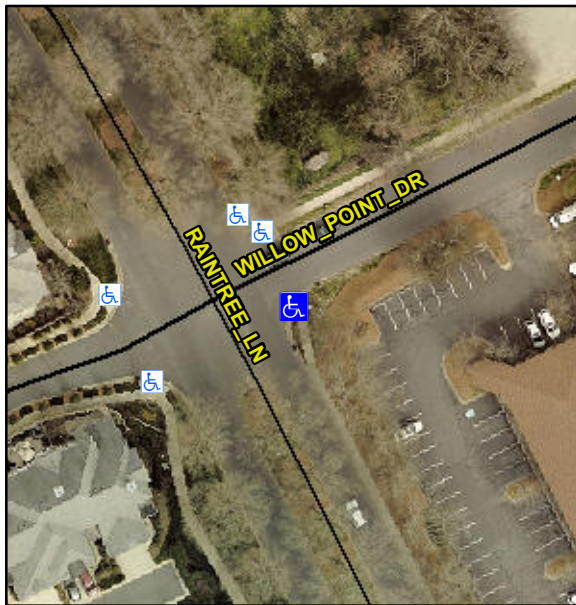
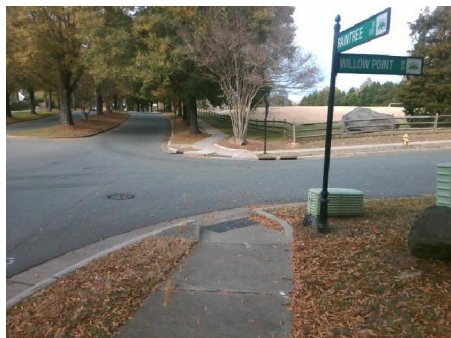
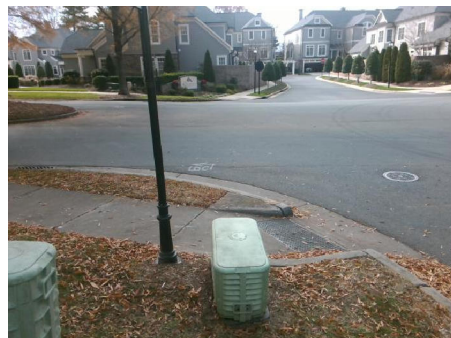
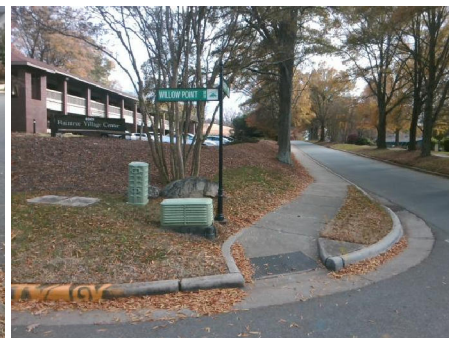
**Not Found, R304.2.2**

Compliance	Description	Data	Compliance	Description	Data
N/A	Ramp Length (in)	68.0	No	Ramp Slope (%)	9.0
Yes	Ramp Width (in)	54.0	Yes	Ramp XSlope (%)	0.5
N/A	Flare Type LT	N/A	N/A	Flare Type RT	N/A
N/A	Flare Slope LT (%)	N/A	N/A	Flare Slope RT (%)	N/A
N/A	Flare Traversable LT?	N/A	N/A	Flare Traversable RT?	N/A
N/A	Landing Length (in)	N/A	N/A	DWS Provided?	N/A
N/A	Landing Width (in)	N/A	N/A	DWS Contrast?	N/A
N/A	Landing Slope (%)	N/A	N/A	DWS Length (in)	N/A
N/A	Landing X Slope (%)	N/A	N/A	DWS Full Width?	N/A
N/A	Landing Curb? (Y/N)	N/A	N/A	DWS Offset (in)	N/A
N/A	Shared Landing?	N/A			
N/A	Gutter Ponding?	N/A	N/A	Gutter Slope (%)	N/A
N/A	Gutter Lip Ht (in)	N/A	N/A	Gutter X Slope (%)	N/A
N/A	Painted X Walk1?	No	N/A	Painted X Walk2?	No
	X Walk 1 Direction	To NW		X Walk 2 Direction	To SW
N/A	X Walk 1 Width (in)	N/A	N/A	X Walk 2 Width (in)	N/A
	X Walk 1 Slope (%)	2.3		X Walk 2 Slope (%)	1.5
	X Walk 1 X Slope (%)	3.8		X Walk 2 X Slope (%)	0.1

N/A	Ramp inside XWalk1?	N/A	N/A	Ramp inside XWalk2?	N/A
	Road Slope (%)	2.0	N/A	Clear Space?	N/A
	Road X Slope (%)	3.1	N/A	Clear Space to XWalk (in)	N/A
N/A	Any Obstructions?	N/A	N/A	Storm Grate/Utility Hazard?	N/A
	Obstruction Type			Storm Grate/Utility Type	
		N/A			N/A
		Yes		Surface Condition? (G/P)	Good

**Remove & Replace Curb Ramp With Two New Directional Ramps or Equivalent.**
