Access Compliance Report

Public Rights-of-Way

(Curb Ramps)

Intersection ID: 2881	Main Street: SWALLOW_TAIL_LN	Cross Street: RED_CLOVER_LN	Location:	N
ADA ID: 6652A6CECDCF	Ramp Type: Perp	Initial Pass/Fail: Fail	Overall Compliance: No	Severity Score: 12.5

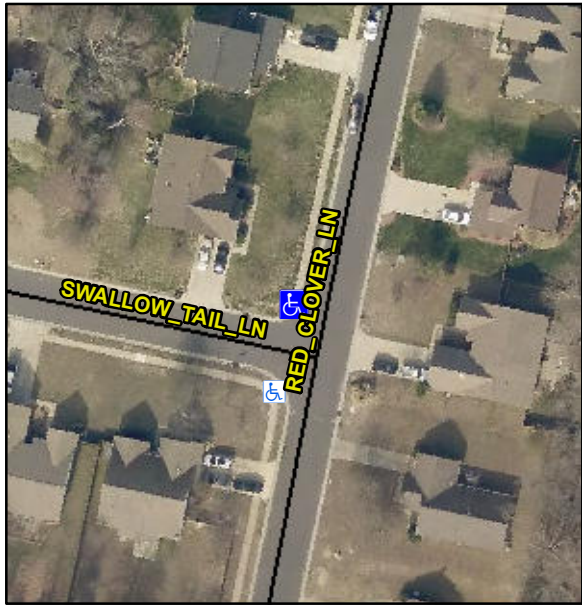
Possible Solutions:		Compliance	Description	Data	Compliance	Description	Data
	Remove & Replace Entire Ramp.		N/A	Ramp Length (in)	51.0	No	Ramp Slope (%)	8.7
			Yes	Ramp Width (in)	48.0	Yes	Ramp XSlope (%)	2.0
			N/A	Flare Type LT	N/A	N/A	Flare Type RT	N/A
			N/A	Flare Slope LT (%)	N/A	N/A	Flare Slope RT (%)	N/A
			N/A	Flare Traversable LT?	N/A	N/A	Flare Traversable RT?	N/A
			N/A	Landing Length (in)	N/A	N/A	DWS Provided?	N/A
			N/A	Landing Width (in)	N/A	N/A	DWS Contrast?	N/A
			N/A	Landing Slope (%)	N/A	N/A	DWS Length (in)	N/A
			N/A	Landing X Slope (%)	N/A	N/A	DWS Full Width?	N/A
Surveyor Notes:		N/A	N/A	Landing Curb? (Y/N)	N/A	N/A	DWS Offset (in)	N/A
PROW/ADA:		Not Found, R304.2.2	N/A	Shared Landing?	N/A			
			N/A	Gutter Ponding?	N/A	N/A	Gutter Slope (%)	N/A
			N/A	Gutter Lip Ht (in)	N/A	N/A	Gutter X Slope (%)	N/A

N/A	Painted X Walk1?	No	N/A	Painted X Walk2?	N/A
				X Walk 1 Direction	To SW		X Walk 2 Direction	N/A
			N/A	X Walk 1 Width (in)	N/A	N/A	X Walk 2 Width (in)	N/A
				X Walk 1 Slope (%)	2.3		X Walk 2 Slope (%)	N/A
				X Walk 1 X Slope (%)	0.5		X Walk 2 X Slope (%)	N/A
			N/A	Ramp inside XWalk1?	N/A	N/A	Ramp inside XWalk2?	N/A
				Road Slope (%)	N/A	N/A	Clear Space?	N/A
				Road X Slope (%)	N/A	N/A	Clear Space to XWalk (in)	N/A
			N/A	Any Obstructions?	N/A	N/A	Storm Grate/Utility Hazard?	N/A
				Obstruction Type			Storm Grate/Utility Type	
					N/A			N/A
						Yes	Surface Condition? (G/P)	Good
Total Cost:		\$ 1850.00
