Access Compliance Report

Public Rights-of-Way

(Curb Ramps)

Intersection ID: 10036062	Main Street: RIVERGATE_PY	Cross Street: N/A	Location: NW
ADA ID: 6654DC130AA0	Ramp Type: Perp	Initial Pass/Fail: Pass	Overall Compliance: No
Codes/Mitigation Info/Possible Solution		Field Measurements/Component Compliance	
Severity Score: 2.5

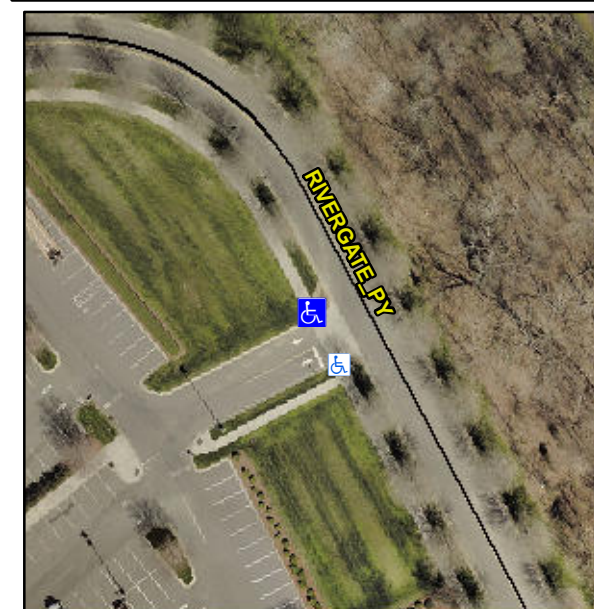
Not Found, R304.2.2-Perp, R304.3.2-Para, R305.1.4, R305.2

Compliance	Description	Data	Compliance	Description	Data
N/A	Ramp Length (in)	122.0	Yes	Ramp Slope (%)	7.2
Yes	Ramp Width (in)	71.0	Yes	Ramp XSlope (%)	1.6
N/A	Flare Type LT	None	N/A	Flare Type RT	N/A
N/A	Flare Slope LT (%)	N/A	N/A	Flare Slope RT (%)	N/A
N/A	Flare Traversable LT?	N/A	N/A	Flare Traversable RT?	N/A
Yes	Landing Length (in)	59.0	Yes	DWS Provided?	Yes
Yes	Landing Width (in)	71.0	Yes	DWS Contrast?	Yes
No	Landing Slope (%)	2.5	Yes	DWS Length (in)	24.0
Yes	Landing X Slope (%)	0.1	No	DWS Full Width?	No
N/A	Landing Curb? (Y/N)	No	No	DWS Offset (in)	6.0
N/A	Shared Landing?	No			
Yes	Gutter Ponding?	No	Yes	Gutter Slope (%)	3.2
Yes	Gutter Lip Ht (in)	0.0	Yes	Gutter X Slope (%)	0.0
N/A	Painted X Walk1?	No	N/A	Painted X Walk2?	N/A
	X Walk 1 Direction	To SE		X Walk 2 Direction	N/A
N/A	X Walk 1 Width (in)	N/A	N/A	X Walk 2 Width (in)	N/A
	X Walk 1 Slope (%)	0.1		X Walk 2 Slope (%)	N/A
	X Walk 1 X Slope (%)	2.4		X Walk 2 X Slope (%)	N/A

N/A	Ramp inside XWalk1?	N/A	N/A	Ramp inside XWalk2?	N/A
	Road Slope (%)	N/A	N/A	Clear Space?	Yes
	Road X Slope (%)	N/A	N/A	Clear Space to XWalk (in)	N/A
Yes	Any Obstructions?	No	Yes	Storm Grate/Utility Hazard?	No
	Obstruction Type			Storm Grate/Utility Type	
		N/A			N/A
			Yes	Surface Condition? (G/P)	Good

Remove & Replace Entire Ramp.
