Access Compliance Report

Public Rights-of-Way

(Curb Ramps)

Intersection ID: 16859	Main Street: ASHMORE_DR	Cross Street: MONROE_RD	Location: NE
ADA ID: 6663DFA1A2D2	Ramp Type: PerpDiag	Initial Pass/Fail: Fail	Overall Compliance: No
Severity Score: 33.75			
Codes/Mitigation Info/Possible Solution		Field Measurements/Component Compliance

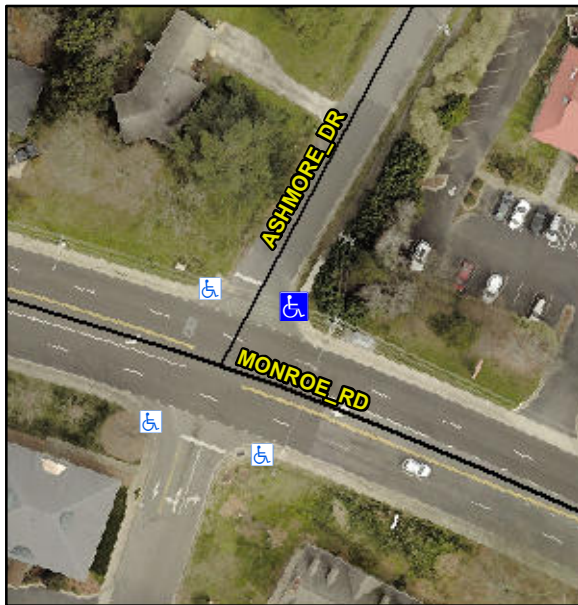
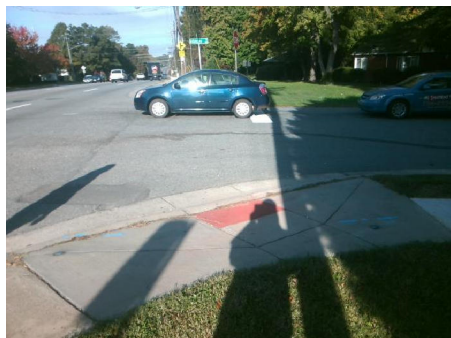
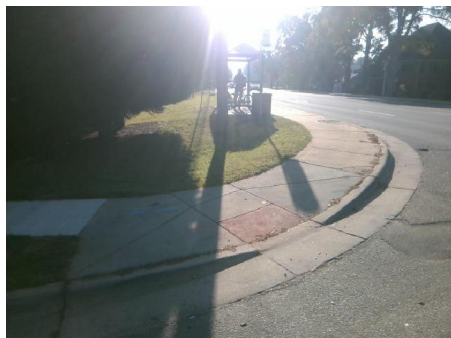
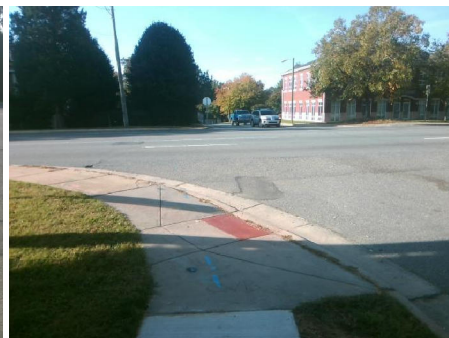
R304.5.1, R304.2.2, R304.5.3

Compliance	Description	Data	Compliance	Description	Data
N/A	Ramp Length (in)	65.0	No	Ramp Slope (%)	8.7
No	Ramp Width (in)	38.0	No	Ramp XSlope (%)	6.0
N/A	Flare Type LT	N/A	N/A	Flare Type RT	N/A
N/A	Flare Slope LT (%)	N/A	N/A	Flare Slope RT (%)	N/A
N/A	Flare Traversable LT?	N/A	N/A	Flare Traversable RT?	N/A
N/A	Landing Length (in)	N/A	N/A	DWS Provided?	N/A
N/A	Landing Width (in)	N/A	N/A	DWS Contrast?	N/A
N/A	Landing Slope (%)	N/A	N/A	DWS Length (in)	N/A
N/A	Landing X Slope (%)	N/A	N/A	DWS Full Width?	N/A
N/A	Landing Curb? (Y/N)	N/A	N/A	DWS Offset (in)	N/A
N/A	Shared Landing?	N/A			
N/A	Gutter Ponding?	N/A	N/A	Gutter Slope (%)	N/A
N/A	Gutter Lip Ht (in)	N/A	N/A	Gutter X Slope (%)	N/A
N/A	Painted X Walk1?	No	N/A	Painted X Walk2?	No
	X Walk 1 Direction	To NW		X Walk 2 Direction	To SW
N/A	X Walk 1 Width (in)	N/A	N/A	X Walk 2 Width (in)	N/A
	X Walk 1 Slope (%)	2.2		X Walk 2 Slope (%)	10.7
	X Walk 1 X Slope (%)	4.1		X Walk 2 X Slope (%)	2.1

N/A	Ramp inside XWalk1?	N/A	N/A	Ramp inside XWalk2?	N/A
	Road Slope (%)	5.9	N/A	Clear Space?	N/A
	Road X Slope (%)	4.8	N/A	Clear Space to XWalk (in)	N/A
N/A	Any Obstructions?	N/A	N/A	Storm Grate/Utility Hazard?	N/A
	Obstruction Type			Storm Grate/Utility Type	
		N/A			N/A
			Yes	Surface Condition? (G/P)	Good

Possible Solutions:

Remove & Replace Curb Ramp With Two New Directional Ramps or Equivalent.
