Access Compliance Report

Public Rights-of-Way

(Curb Ramps)

Intersection ID: 30295	Main Street: CABOT_HILL_CT	Cross Street: HAMPTON_WAY_DR	Location: SW
ADA ID: 66673FB688FB	Ramp Type: BlendTrans1	Initial Pass/Fail: Fail	Overall Compliance: No
Severity Score: 10			
Codes/Mitigation Info/Possible Solution		Field Measurements/Component Compliance

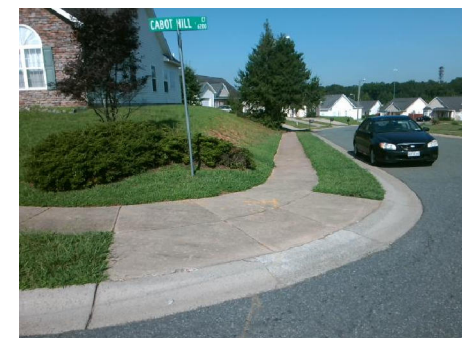
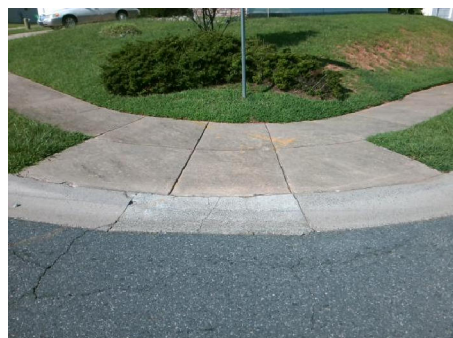
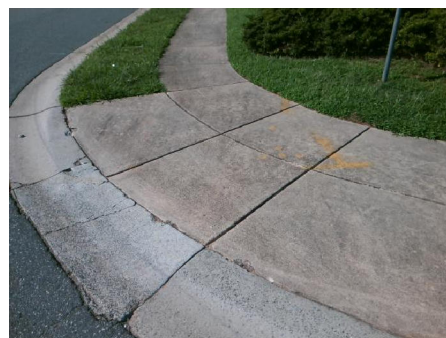
DAMAGED CURB/GTR

Not Found, R304.5.1, R304.5.3

Compliance	Description	Data	Compliance	Description	Data
N/A	Ramp Length (in)	48.0	Yes	BlendTrans Slope (%)	4.9
No	Ramp Width (in)	41.0	No	BlendTrans XSlope (%)	2.5
N/A	Flare Type LT	N/A	N/A	Flare Type RT	N/A
N/A	Flare Slope LT (%)	N/A	N/A	Flare Slope RT (%)	N/A
N/A	Flare Traversable LT?	N/A	N/A	Flare Traversable RT?	N/A
N/A	Landing Length (in)	N/A	N/A	DWS Provided?	N/A
N/A	Landing Width (in)	N/A	N/A	DWS Contrast?	N/A
N/A	Landing Slope (%)	N/A	N/A	DWS Length (in)	N/A
N/A	Landing X Slope (%)	N/A	N/A	DWS Full Width?	N/A
N/A	Landing Curb? (Y/N)	N/A	N/A	DWS Offset (in)	N/A
N/A	Shared Landing?	N/A			
N/A	Gutter Ponding?	N/A	N/A	Gutter Slope (%)	N/A
N/A	Gutter Lip Ht (in)	N/A	N/A	Gutter X Slope (%)	N/A
N/A	Painted X Walk1?	No	N/A	Painted X Walk2?	No
	X Walk 1 Direction	To E		X Walk 2 Direction	To N
	X Walk 1 Width (in)	N/A		X Walk 2 Width (in)	N/A
	X Walk 1 Slope (%)	5.0		X Walk 2 Slope (%)	0.9
	X Walk 1 X Slope (%)	1.7		X Walk 2 X Slope (%)	3.3

N/A	Ramp inside XWalk1?	N/A	N/A	Ramp inside XWalk2?	N/A
	Road Slope (%)	3.3		Clear Space?	N/A
	Road X Slope (%)	2.4	N/A	Clear Space to XWalk (in)	N/A
N/A	Any Obstructions?	N/A	N/A	Storm Grate/Utility Hazard?	N/A
	Obstruction Type			Storm Grate/Utility Type	
		N/A			N/A
			Yes	Surface Condition? (G/P)	Good
			No	Curb Slope (%)	26.6

Remove & Replace Curb Ramp With Two New Directional Ramps or Equivalent.
