## **Access Compliance Report Public Rights-of-Way** (Curb Ramps)

Intersection ID: 31934 Main Street: STEELE CREEK RD **Cross Street: BRANCH BEND LN** Location: NW **Severity Score:** ADA ID: 6671F4E29990 Ramp Type: BlendTrans2 Initial Pass/Fail: Fail **Overall Compliance: No** 25

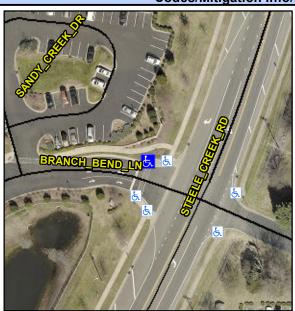
Field Measurements/Component Compliance					
Compliance Description		Data	Compliance Description		Data
N/A	Ramp Length (in)	69.0	Yes	BlendTrans Slope (%)	2.9
Yes	Ramp Width (in)	60.0	No	BlendTrans XSlope (%)	7.6
N/A	Flare Type LT	N/A	N/A	Flare Type RT	N/A
N/A	Flare Slope LT (%)	N/A	N/A	Flare Slope RT (%)	N/A
N/A	Flare Traversable LT?	N/A	N/A	Flare Traversable RT?	N/A
N/A	Landing Length (in)	N/A	N/A	DWS Provided?	N/A
N/A	Landing Width (in)	N/A	N/A	DWS Contrast?	N/A
N/A	Landing Slope (%)	N/A	N/A	DWS Length (in)	N/A
N/A	Landing X Slope (%)	N/A	N/A	DWS Full Width?	N/A
N/A	Landing Curb? (Y/N)	N/A	N/A	DWS Offset (in)	N/A
N/A	Shared Landing?	N/A			
N/A	Gutter Ponding?	N/A	N/A	Gutter Slope (%)	N/A
N/A	Gutter Lip Ht (in)	N/A	N/A	Gutter X Slope (%)	N/A
N/A	Painted X Walk1?	Yes	N/A	Painted X Walk2?	N/A
	X Walk 1 Direction	To SW		X Walk 2 Direction	N/A
	X Walk 1 Width (in)	61.0		X Walk 2 Width (in)	N/A
	X Walk 1 Slope (%)	0.4		X Walk 2 Slope (%)	N/A

X Walk 1 X Slope (%)	2.7		X Walk 2 X Slope (%)	N/A
N/A	Ramp inside XWalk1?	Yes	N/A	Ramp inside XWalk2?	N/A
	Road Slope (%)	2.7		Clear Space?	N/A
	Road X Slope (%)	0.4	N/A	Clear Space to XWalk (in)	N/A
N/A	Any Obstructions?	N/A	N/A	Storm Grate/Utility Hazard?	N/A
	Obstruction Type			Storm Grate/Utility Type	
		N/A			N/A
			Yes	Surface Condition? (G/P)	Good
1			N/A	Curb Slope (%)	1.6
	12( P

Possible Solutions: Remove & Replace Curb Ramp With **Two New Directional Ramps or** Equivalent. Surveyor Notes: N/A PROW/ADA:
