Access Compliance Report

Public Rights-of-Way

(Curb Ramps)

Intersection ID: 14864	Main Street: E_TREMONT_AV	Cross Street: LENNOX_AV	Location:	E
ADA ID: 66730056A75E	Ramp Type: Directional1	Initial Pass/Fail: Fail	Overall Compliance: No	Severity Score: 10
Codes/Mitigation Info/Possible Solution		Field Measurements/Component Compliance

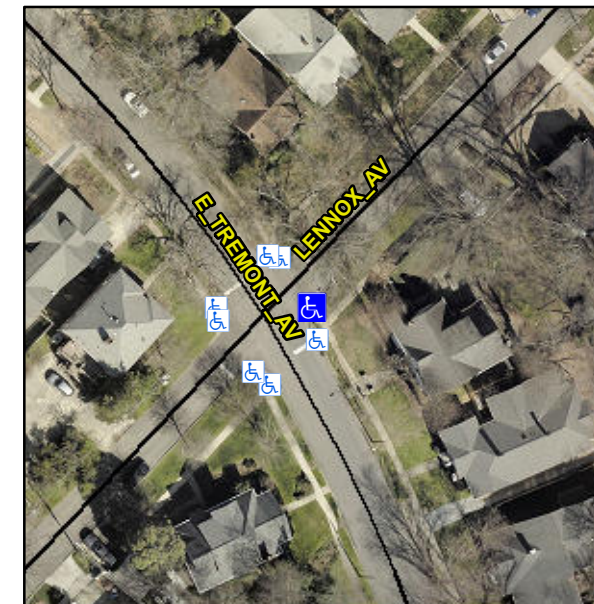
Compliance	Description	Data	Compliance	Description	Data
N/A	Ramp Length (in)	115.0	N/A	Grade Break?	N/A
No	Ramp Width (in)	42.0	N/A	Grade Break Slope (%)	0.0
Yes	Ramp Slope (%)	5.5	N/A	Grade Break XSlope (%)	0.0
No	Ramp XSlope (%)	3.0			
N/A	Flare Type LT	N/A	N/A	Flare Type RT	N/A
N/A	Flare Slope LT (%)	N/A	N/A	Flare Slope RT (%)	0.0
N/A	Flare Traversable LT?	N/A	N/A	Flare Traversable RT?	N/A
N/A	Landing Length (in)	0.0	N/A	DWS Provided?	N/A
N/A	Landing Width (in)	0.0	N/A	DWS Contrast?	N/A
N/A	Landing Slope (%)	0.0	N/A	DWS Length (in)	N/A
N/A	Landing X Slope (%)	0.0	N/A	DWS Full Width?	N/A
N/A	Landing Curb? (Y/N)	N/A	N/A	DWS Offset LT (in)	N/A
N/A	Shared Landing?	N/A	N/A	DWS Offset RT (in)	N/A
N/A	Gutter Ponding?	0.0	N/A	Gutter Slope (%)	N/A
N/A	Gutter Lip Ht (in)	1.0	N/A	Gutter X Slope (%)	N/A
N/A	Painted X Walk1?	No		Road Slope (%)	0.4
	X Walk 1 Direction	To NW		Road X Slope (%)	0.6
	X Walk 1 Width (in)	N/A		Clear Space?	N/A

X Walk 1 Slope (%)	0.4	N/A	Clear Space to XWalk (in)	N/A
	X Walk 1 X Slope (%)	0.6	N/A	Storm Grate/Utility Hazard?	N/A
N/A	Ramp inside XWalk1?	N/A		Storm Grate/Utility Type	
N/A	Any Obstructions?	N/A			N/A
	Obstruction Type		Yes	Surface Condition? (G/P)	Good
			N/A	Curb Slope (%)	2.1

Possible Solutions:

Remove & Replace Entire Ramp.
