Access Compliance Report

Public Rights-of-Way

(Curb Ramps)

Intersection ID: 13016	Main Street: HOLLY_HILL_RD	Cross Street: PENCE_RD	Location: SE
ADA ID: 667454417C63	Ramp Type: Perp	Initial Pass/Fail: Fail	Overall Compliance: No
Severity Score: 21.25			
Codes/Mitigation Info/Possible Solution		Field Measurements/Component Compliance

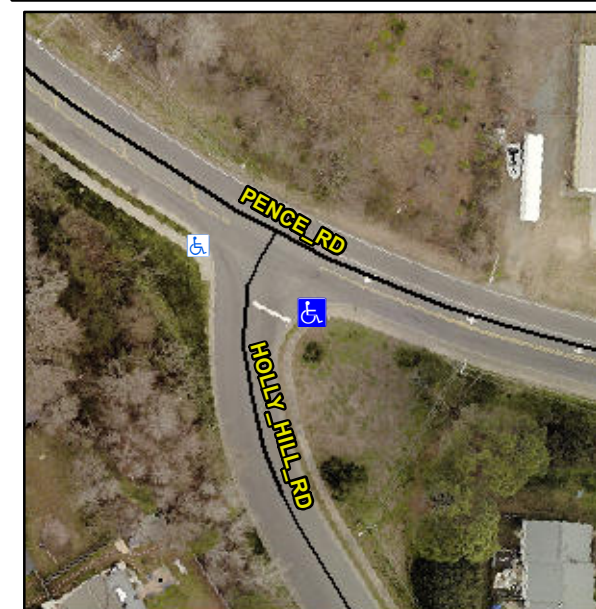
Not Found, R304.5.1, R304.2.2

Compliance	Description	Data	Compliance	Description	Data
N/A	Ramp Length (in)	66.0	No	Ramp Slope (%)	10.0
No	Ramp Width (in)	36.0	Yes	Ramp XSlope (%)	0.0
N/A	Flare Type LT	N/A	N/A	Flare Type RT	N/A
N/A	Flare Slope LT (%)	N/A	N/A	Flare Slope RT (%)	N/A
N/A	Flare Traversable LT?	N/A	N/A	Flare Traversable RT?	N/A
N/A	Landing Length (in)	N/A	N/A	DWS Provided?	N/A
N/A	Landing Width (in)	N/A	N/A	DWS Contrast?	N/A
N/A	Landing Slope (%)	N/A	N/A	DWS Length (in)	N/A
N/A	Landing X Slope (%)	N/A	N/A	DWS Full Width?	N/A
N/A	Landing Curb? (Y/N)	N/A	N/A	DWS Offset (in)	N/A
N/A	Shared Landing?	N/A			
N/A	Gutter Ponding?	N/A	N/A	Gutter Slope (%)	N/A
N/A	Gutter Lip Ht (in)	N/A	N/A	Gutter X Slope (%)	N/A
N/A	Painted X Walk1?	No	N/A	Painted X Walk2?	N/A
	X Walk 1 Direction	To NW		X Walk 2 Direction	N/A
N/A	X Walk 1 Width (in)	N/A	N/A	X Walk 2 Width (in)	N/A
	X Walk 1 Slope (%)	0.2		X Walk 2 Slope (%)	N/A
	X Walk 1 X Slope (%)	0.9		X Walk 2 X Slope (%)	N/A

N/A	Ramp inside XWalk1?	N/A	N/A	Ramp inside XWalk2?	N/A
	Road Slope (%)	N/A	N/A	Clear Space?	N/A
	Road X Slope (%)	N/A	N/A	Clear Space to XWalk (in)	N/A
N/A	Any Obstructions?	N/A	N/A	Storm Grate/Utility Hazard?	N/A
	Obstruction Type			Storm Grate/Utility Type	
		N/A			N/A
			Yes	Surface Condition? (G/P)	Good

Possible Solutions:

Remove & Replace Entire Ramp.
