Access Compliance Report

Public Rights-of-Way

(Curb Ramps)

Intersection ID: 18387	Main Street: BURTONWOOD_CR	Cross Street: MONROE_RD	Location: SE
ADA ID: 667A2426EA5D	Ramp Type: PerpDiag	Initial Pass/Fail: Fail	Overall Compliance: No
Severity Score: 37.5			
Codes/Mitigation Info/Possible Solution		Field Measurements/Component Compliance

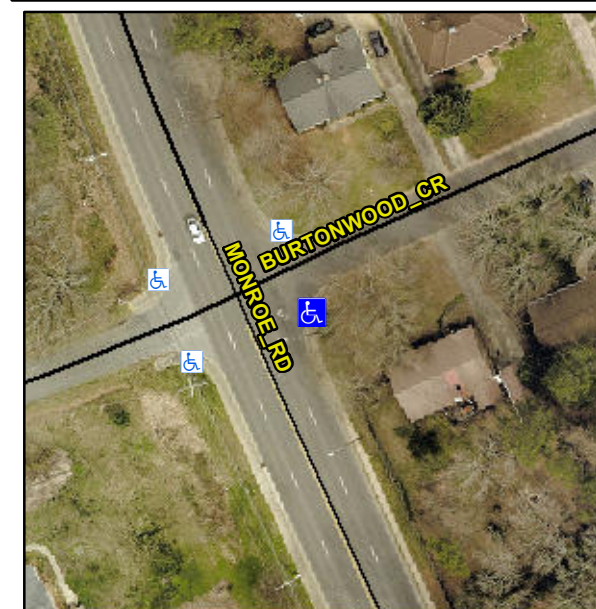
Not Found, R304.2.2, R304.5.3

Compliance	Description	Data	Compliance	Description	Data
N/A	Ramp Length (in)	58.0	No	Ramp Slope (%)	10.6
Yes	Ramp Width (in)	48.0	No	Ramp XSlope (%)	7.2
N/A	Flare Type LT	N/A	N/A	Flare Type RT	N/A
N/A	Flare Slope LT (%)	N/A	N/A	Flare Slope RT (%)	N/A
N/A	Flare Traversable LT?	N/A	N/A	Flare Traversable RT?	N/A
N/A	Landing Length (in)	N/A	N/A	DWS Provided?	N/A
N/A	Landing Width (in)	N/A	N/A	DWS Contrast?	N/A
N/A	Landing Slope (%)	N/A	N/A	DWS Length (in)	N/A
N/A	Landing X Slope (%)	N/A	N/A	DWS Full Width?	N/A
N/A	Landing Curb? (Y/N)	N/A	N/A	DWS Offset (in)	N/A
N/A	Shared Landing?	N/A			
N/A	Gutter Ponding?	N/A	N/A	Gutter Slope (%)	N/A
N/A	Gutter Lip Ht (in)	N/A	N/A	Gutter X Slope (%)	N/A
N/A	Painted X Walk1?	No	N/A	Painted X Walk2?	No
	X Walk 1 Direction	To N		X Walk 2 Direction	To W
N/A	X Walk 1 Width (in)	N/A	N/A	X Walk 2 Width (in)	N/A
	X Walk 1 Slope (%)	3.8		X Walk 2 Slope (%)	0.8
	X Walk 1 X Slope (%)	0.1		X Walk 2 X Slope (%)	4.5

N/A	Ramp inside XWalk1?	N/A	N/A	Ramp inside XWalk2?	N/A
	Road Slope (%)	2.1	N/A	Clear Space?	N/A
	Road X Slope (%)	4.6	N/A	Clear Space to XWalk (in)	N/A
N/A	Any Obstructions?	N/A	N/A	Storm Grate/Utility Hazard?	N/A
	Obstruction Type			Storm Grate/Utility Type	
		N/A			N/A
		Yes		Surface Condition? (G/P)	Good

Possible Solutions:

Remove & Replace Curb Ramp With Two New Directional Ramps or Equivalent.
