# Access Compliance Report

## Public Rights-of-Way

### (Curb Ramps)

Intersection ID: 10014737	Main Street: ROCKY_RIVER_RD	Cross Street: N/A	Location: SE
ADA ID: 6680BFEBFB87	Ramp Type: PerpDiag	Initial Pass/Fail: Fail	Overall Compliance: No
Severity Score: 12.5			
Codes/Mitigation Info/Possible Solution		Field Measurements/Component Compliance

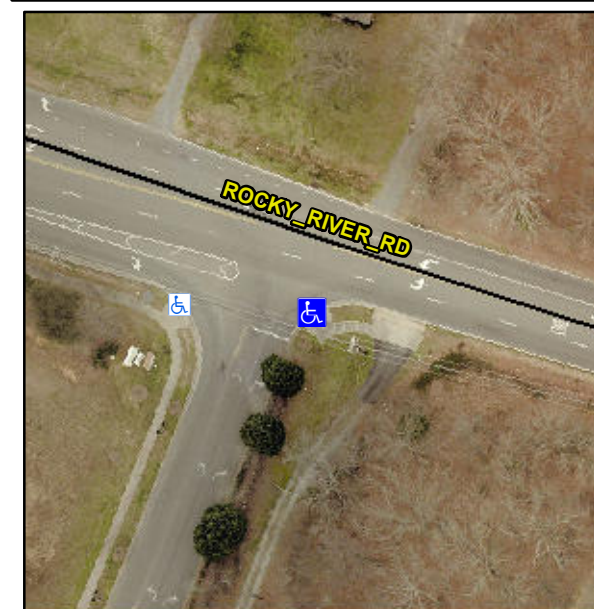
**Not Found, R304.5.3**

Compliance	Description	Data	Compliance	Description	Data
N/A	Ramp Length (in)	94.0	Yes	Ramp Slope (%)	6.8
Yes	Ramp Width (in)	50.0	No	Ramp XSlope (%)	5.2
N/A	Flare Type LT	N/A	N/A	Flare Type RT	N/A
N/A	Flare Slope LT (%)	N/A	N/A	Flare Slope RT (%)	N/A
N/A	Flare Traversable LT?	N/A	N/A	Flare Traversable RT?	N/A
N/A	Landing Length (in)	N/A	N/A	DWS Provided?	N/A
N/A	Landing Width (in)	N/A	N/A	DWS Contrast?	N/A
N/A	Landing Slope (%)	N/A	N/A	DWS Length (in)	N/A
N/A	Landing X Slope (%)	N/A	N/A	DWS Full Width?	N/A
N/A	Landing Curb? (Y/N)	N/A	N/A	DWS Offset (in)	N/A
N/A	Shared Landing?	N/A			
N/A	Gutter Ponding?	N/A	N/A	Gutter Slope (%)	N/A
N/A	Gutter Lip Ht (in)	N/A	N/A	Gutter X Slope (%)	N/A
N/A	Painted X Walk1?	No	N/A	Painted X Walk2?	No
	X Walk 1 Direction	To N		X Walk 2 Direction	To W
N/A	X Walk 1 Width (in)	N/A	N/A	X Walk 2 Width (in)	N/A
	X Walk 1 Slope (%)	5.6		X Walk 2 Slope (%)	0.8
	X Walk 1 X Slope (%)	1.0		X Walk 2 X Slope (%)	3.4

N/A	Ramp inside XWalk1?	N/A	N/A	Ramp inside XWalk2?	N/A
	Road Slope (%)	3.3	N/A	Clear Space?	N/A
	Road X Slope (%)	3.4	N/A	Clear Space to XWalk (in)	N/A
N/A	Any Obstructions?	N/A	N/A	Storm Grate/Utility Hazard?	N/A
	Obstruction Type			Storm Grate/Utility Type	
		N/A			N/A
		Yes		Surface Condition? (G/P)	Good

**Remove & Replace Curb Ramp With Two New Directional Ramps or Equivalent.**

Total Cost: \$ 3200.00
