# Access Compliance Report

## Public Rights-of-Way

| Intersection ID: 52293 | Main Street: N_I-85_SERVICE_RD | Cross Street: N_TRYON_ST | Location: | N |
| ADA ID: 6691EF6281D1 | Ramp Type: Directional1 | Initial Pass/Fail: Pass | Overall Compliance: No | Severity Score: 15 |

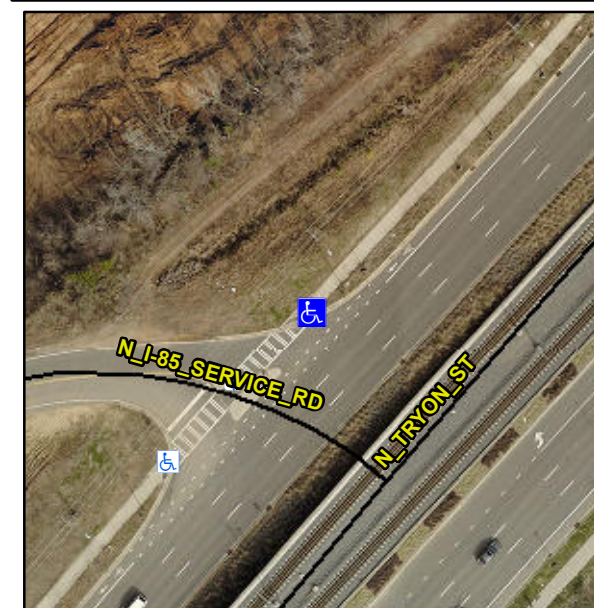
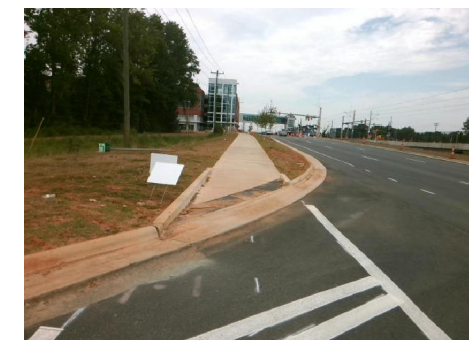
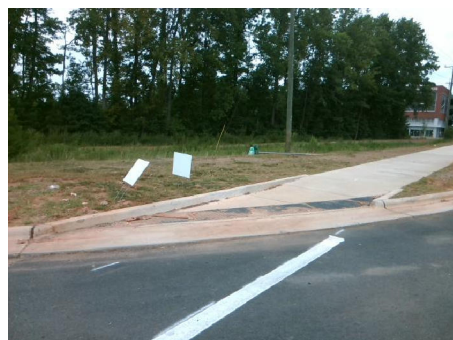
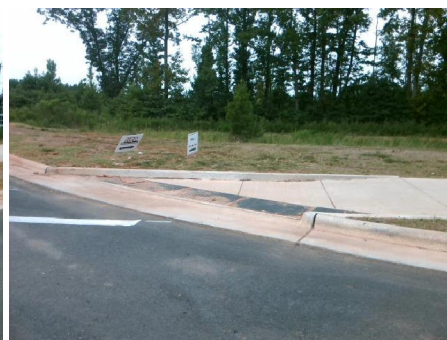
**Not Found, R304.2.2-Perp, R304.3.2-Para, R304.5.3, R304.5.2, R302.7, R302.7.2**

| Compliance | Description | Data | Compliance | Description | Data |
|---|---|---|---|---|---|
| No | Landing Slope (%) | 2.1 | Yes | DWS Length (in) | 24.0 |
| No | Landing X Slope (%) | 2.1 | Yes | DWS Full Width? | Yes |
| No | Gutter Ponding? | Yes | Yes | Gutter Slope (%) | 3.1 |
| No | Gutter Lip Ht (in) | 2.0 | Yes | Gutter X Slope (%) | 1.4 |

**Remove & Replace Entire Ramp.**

Total Cost: \$ 1600.00
