Access Compliance Report

Public Rights-of-Way (Curb Ramps)

Intersection ID: 50595	Main Street: BENDING_BRANCH_RD	Cross Street: GRAY_WILLOW_RD	Location:	N
ADA ID: 66960B90EEA9	Ramp Type: Perp	Initial Pass/Fail: Fail	Overall Compliance: No	Severity Score: 33.75

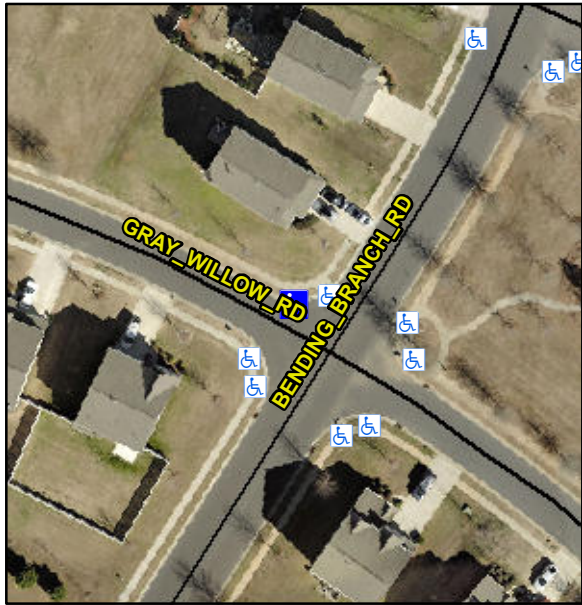
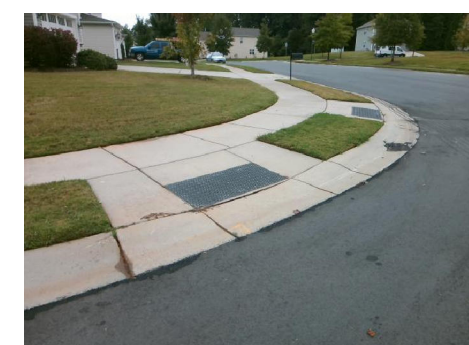
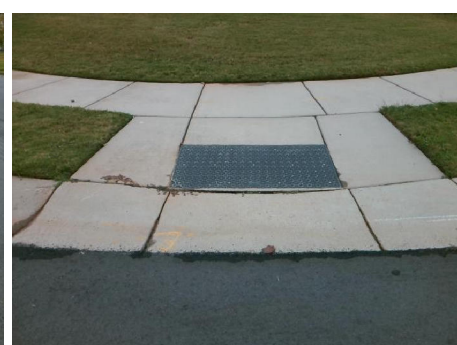
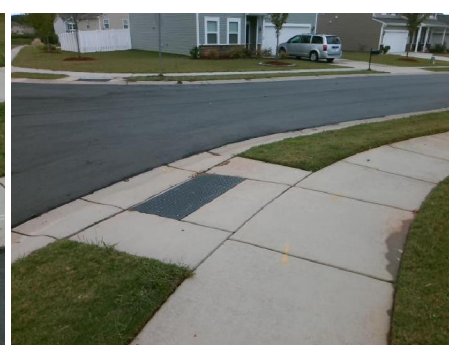
Possible Solutions:		Compliance	Description	Data	Compliance	Description	Data
	Remove & Replace Entire Ramp.		N/A	Ramp Length (in)	47.5	No	Ramp Slope (%)	13.5
			No	Ramp Width (in)	47.0	Yes	Ramp XSlope (%)	1.4
			N/A	Flare Type LT	N/A	N/A	Flare Type RT	N/A
			N/A	Flare Slope LT (%)	N/A	N/A	Flare Slope RT (%)	N/A
			N/A	Flare Traversable LT?	N/A	N/A	Flare Traversable RT?	N/A
			N/A	Landing Length (in)	N/A	N/A	DWS Provided?	N/A
			N/A	Landing Width (in)	N/A	N/A	DWS Contrast?	N/A
			N/A	Landing Slope (%)	N/A	N/A	DWS Length (in)	N/A
			N/A	Landing X Slope (%)	N/A	N/A	DWS Full Width?	N/A
Surveyor Notes:		N/A	N/A	Landing Curb? (Y/N)	N/A	N/A	DWS Offset (in)	N/A
PROW/ADA:		Not Found, R304.5.1, R304.2.2	N/A	Shared Landing?	N/A			
			N/A	Gutter Ponding?	N/A	N/A	Gutter Slope (%)	N/A
			N/A	Gutter Lip Ht (in)	N/A	N/A	Gutter X Slope (%)	N/A

N/A	Painted X Walk1?	No	N/A	Painted X Walk2?	N/A
				X Walk 1 Direction	To SW		X Walk 2 Direction	N/A
			N/A	X Walk 1 Width (in)	N/A	N/A	X Walk 2 Width (in)	N/A
				X Walk 1 Slope (%)	0.9		X Walk 2 Slope (%)	N/A
				X Walk 1 X Slope (%)	1.5		X Walk 2 X Slope (%)	N/A
			N/A	Ramp inside XWalk1?	N/A	N/A	Ramp inside XWalk2?	N/A
				Road Slope (%)	N/A	N/A	Clear Space?	N/A
				Road X Slope (%)	N/A	N/A	Clear Space to XWalk (in)	N/A
			N/A	Any Obstructions?	N/A	N/A	Storm Grate/Utility Hazard?	N/A
				Obstruction Type			Storm Grate/Utility Type	
						N/A		N/A
						Yes	Surface Condition? (G/P)	Good
							</
