# Access Compliance Report

## Public Rights-of-Way

### (Curb Ramps)

Intersection ID: 10037201	Main Street: SANDY_PORTER_RD	Cross Street: N/A	Location: NE
ADA ID: 66963CE20A75	Ramp Type: PerpDiag	Initial Pass/Fail: Fail	Overall Compliance: No
		Severity Score: 8.75

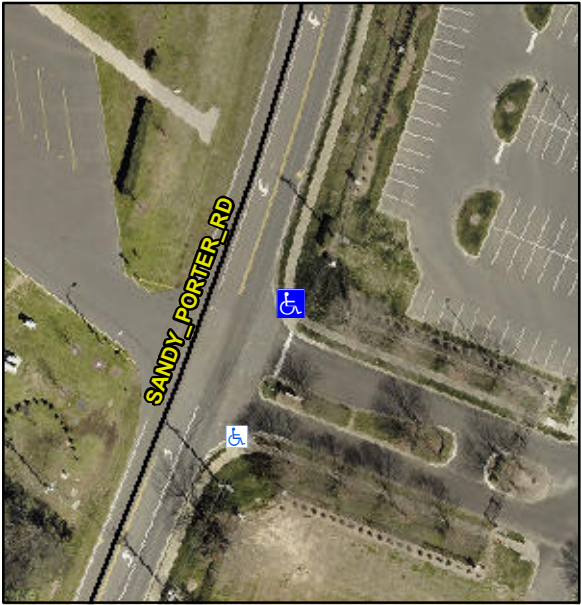
Possible Solutions:		<b>Compliance</b>	<b>Description</b>	<b>Data</b>
	<b>Remove &amp; Replace Curb Ramp With Two New Directional Ramps or Equivalent.</b>		<b>N/A</b>	Ramp Length (in)	<b>52.0</b>
			<b>No</b>	Ramp Width (in)	<b>38.0</b>
			<b>N/A</b>	Flare Type LT	<b>N/A</b>
			<b>N/A</b>	Flare Slope LT (%)	<b>N/A</b>
			<b>N/A</b>	Flare Traversable LT?	<b>N/A</b>
			<b>N/A</b>	Landing Length (in)	<b>N/A</b>
			<b>N/A</b>	Landing Width (in)	<b>N/A</b>
			<b>N/A</b>	Landing Slope (%)	<b>N/A</b>
			<b>N/A</b>	Landing X Slope (%)	<b>N/A</b>
<p>Surveyor Notes:</p> <p><b>N/A</b></p> <p>PROW/ADA:</p> <p><b>Not Found, R304.5.1</b></p>			<b>N/A</b>	Flare Type RT	<b>N/A</b>
			<b>N/A</b>	Flare Slope RT (%)	<b>N/A</b>
			<b>N/A</b>	Flare Traversable RT?	<b>N/A</b>
			<b>N/A</b>	DWS Provided?	<b>N/A</b>
			<b>N/A</b>	DWS Contrast?	<b>N/A</b>

<b>N/A</b>	DWS Length (in)	<b>N/A</b>
			<b>N/A</b>	DWS Full Width?	<b>N/A</b>
			<b>N/A</b>	DWS Offset (in)	<b>N/A</b>
			<b>N/A</b>	Gutter Ponding?	<b>N/A</b>
			<b>N/A</b>	Gutter Lip Ht (in)	<b>N/A</b>
			<b>No</b>	Painted X Walk1?	<b>No</b>
				X Walk 1 Direction	<b>To NW</b>
			<b>N/A</b>	X Walk 1 Width (in)	<b>N/A</b>
				X Walk 1 Slope (%)	<b>1.6</b>
				X Walk 1 X Slope (%)	<b>0.1</b>
			<b>N/A</b>	X Walk 2 Direction	<b>To SW</b>
			<b>N/A</b>	X Walk 2 Width (in)	<b>N/A</b>
				X Walk 2 Slope (%)	<b>1.1</b>
				X Walk 2 X Slope (%)	<b>2.3</b>
			<b>N/A</b>	Ramp inside XWalk1?	<b>N/A</b>
			<b>N/A</b>	Ramp inside XWalk2?	<b>N/A</b>
			<b>1.1</b>	Clear Space?	<b>N/A</b>
			<b>0.8</b>	Clear Space to XWalk (in)	<b>N/A</b>
			<b>N/A</b>	Storm Grate/Utility Hazard?	<b>N/A</b>
				Storm Grate/Utility Type	
			<b>N/A</b>		<b>N/A</b>
			<b>Yes</b>	Surface Condition? (G/P)	<b>Good</b>
Total Cost:		\$ 3200.00
