Access Compliance Report

Public Rights-of-Way

(Curb Ramps)

Intersection ID: N/A	Main Street: BOYCE_RD	Cross Street: TOBIN_CT	Location: NE
ADA ID: 669B8EB88CE5	Ramp Type: Directional1	Initial Pass/Fail: Fail	Overall Compliance: No
Codes/Mitigation Info/Possible Solution		Field Measurements/Component Compliance	
Severity Score: 13.75

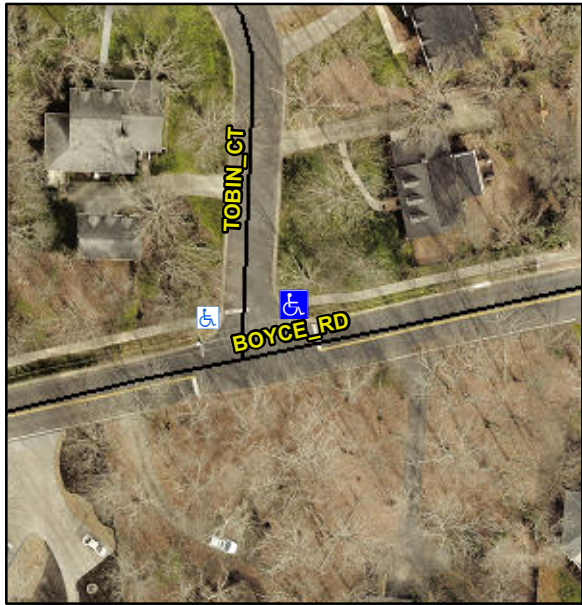
Compliance	Description	Data	Compliance	Description	Data
N/A	Ramp Length (in)	88.0	N/A	Grade Break?	N/A
Yes	Ramp Width (in)	48.0	N/A	Grade Break Slope (%)	0.0
No	Ramp Slope (%)	8.4	N/A	Grade Break XSlope (%)	0.0
No	Ramp XSlope (%)	3.7			
N/A	Flare Type LT	N/A	N/A	Flare Type RT	N/A
N/A	Flare Slope LT (%)	N/A	N/A	Flare Slope RT (%)	0.0
N/A	Flare Traversable LT?	N/A	N/A	Flare Traversable RT?	N/A
N/A	Landing Length (in)	0.0	N/A	DWS Provided?	N/A
N/A	Landing Width (in)	0.0	N/A	DWS Contrast?	N/A
N/A	Landing Slope (%)	0.0	N/A	DWS Length (in)	N/A
N/A	Landing X Slope (%)	0.0	N/A	DWS Full Width?	N/A
N/A	Landing Curb? (Y/N)	N/A	N/A	DWS Offset LT (in)	N/A
N/A	Shared Landing?	N/A	N/A	DWS Offset RT (in)	N/A
N/A	Gutter Ponding?	0.0	N/A	Gutter Slope (%)	N/A
N/A	Gutter Lip Ht (in)	0.0	N/A	Gutter X Slope (%)	N/A
N/A	Painted X Walk1?	No		Road Slope (%)	0.0
	X Walk 1 Direction	To W		Road X Slope (%)	6.4
	X Walk 1 Width (in)	N/A		Clear Space?	N/A

X Walk 1 Slope (%)	0.0	N/A	Clear Space to XWalk (in)	N/A
	X Walk 1 X Slope (%)	6.4	N/A	Storm Grate/Utility Hazard?	N/A
N/A	Ramp inside XWalk1?	N/A		Storm Grate/Utility Type	
N/A	Any Obstructions?	N/A			N/A
	Obstruction Type		Yes	Surface Condition? (G/P)	Good
		N/A	N/A	Curb Slope (%)	4.9

Possible Solutions:

Remove & Replace Entire Ramp.

R304.2.2, R304.5.3
