# Access Compliance Report

## Public Rights-of-Way

| Intersection ID: 27200 | Main Street: ANNALEXA_LN | Cross Street: BALLANTYNE_COMMONS_PY | Location: SW |
| ADA ID: 66A1B116E03A | Ramp Type: Perp | Initial Pass/Fail: Fail | Overall Compliance: No<br>Severity Score: 21.25 |

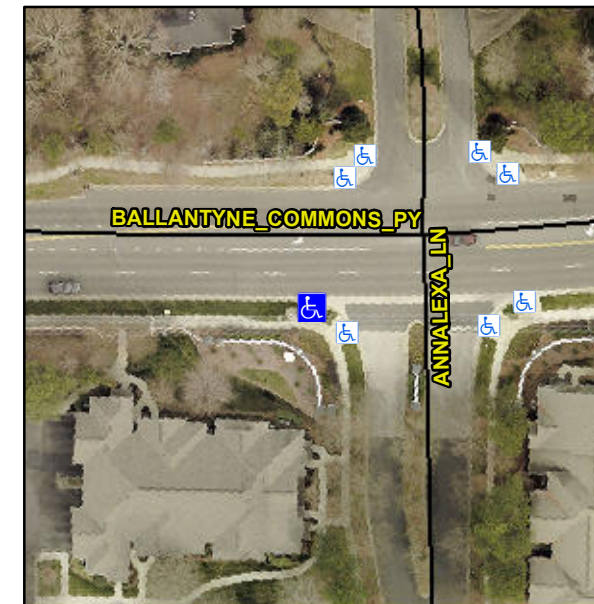
**R304.5.1, R304.2.2**

| Compliance | Description | Data | Compliance | Description | Data |
|---|---|---|---|---|---|
| N/A | Ramp Length (in) | 92.0 | No | Ramp Slope (%) | 8.7 |
| No | Ramp Width (in) | 42.0 | Yes | Ramp XSlope (%) | 1.5 |

**Remove & Replace Entire Ramp.**
