Access Compliance Report

Public Rights-of-Way

(Curb Ramps)

Intersection ID: N/A	Main Street: BURKHARD_WY	Cross Street: SPRINGBANK_LN	Location: NW
ADA ID: 66A8EF48D6AF	Ramp Type: PerpDiag	Initial Pass/Fail: Fail	Overall Compliance: No
		Severity Score: 25

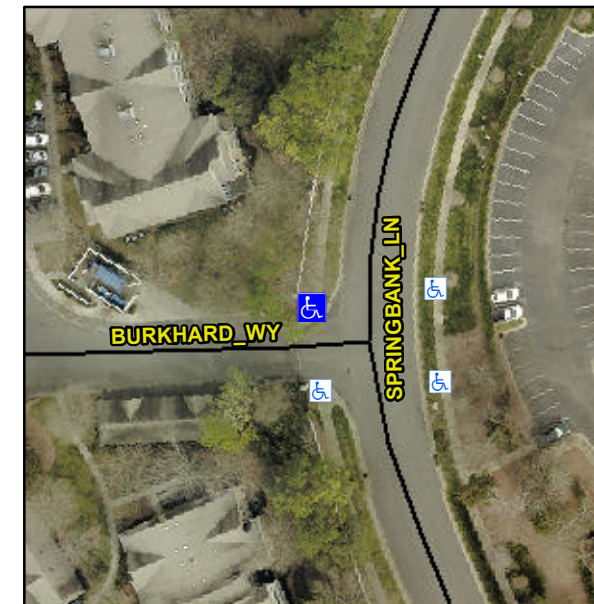
R304.2.2, R304.5.3

Compliance	Description	Data	Compliance	Description	Data
N/A	Ramp Length (in)	77.0	No	Ramp Slope (%)	8.7
Yes	Ramp Width (in)	63.0	No	Ramp XSlope (%)	6.3
N/A	Flare Type LT	N/A	N/A	Flare Type RT	N/A
N/A	Flare Slope LT (%)	N/A	N/A	Flare Slope RT (%)	N/A
N/A	Flare Traversable LT?	N/A	N/A	Flare Traversable RT?	N/A
N/A	Landing Length (in)	N/A	N/A	DWS Provided?	N/A
N/A	Landing Width (in)	N/A	N/A	DWS Contrast?	N/A
N/A	Landing Slope (%)	N/A	N/A	DWS Length (in)	N/A
N/A	Landing X Slope (%)	N/A	N/A	DWS Full Width?	N/A
N/A	Landing Curb? (Y/N)	N/A	N/A	DWS Offset (in)	N/A
N/A	Shared Landing?	N/A			
N/A	Gutter Ponding?	N/A	N/A	Gutter Slope (%)	N/A
N/A	Gutter Lip Ht (in)	N/A	N/A	Gutter X Slope (%)	N/A
N/A	Painted X Walk1?	No	N/A	Painted X Walk2?	No
	X Walk 1 Direction	To S		X Walk 2 Direction	To E
N/A	X Walk 1 Width (in)	N/A	N/A	X Walk 2 Width (in)	N/A
	X Walk 1 Slope (%)	2.0		X Walk 2 Slope (%)	4.8
	X Walk 1 X Slope (%)	6.5		X Walk 2 X Slope (%)	0.8

N/A	Ramp inside XWalk1?	N/A	N/A	Ramp inside XWalk2?	N/A
	Road Slope (%)	4.0	N/A	Clear Space?	N/A
	Road X Slope (%)	5.6	N/A	Clear Space to XWalk (in)	N/A
N/A	Any Obstructions?	N/A	N/A	Storm Grate/Utility Hazard?	N/A
	Obstruction Type			Storm Grate/Utility Type	
		N/A			N/A
		Yes		Surface Condition? (G/P)	Good

Remove & Replace Curb Ramp With Two New Directional Ramps or Equivalent.

Total Cost: \$ 3200.00
