Access Compliance Report

Public Rights-of-Way

(Curb Ramps)

Intersection ID: N/A	Main Street: HOSTA_DR	Cross Street: N/A	Location: NW
ADA ID: 66AE555B7396	Ramp Type: PerpDiag	Initial Pass/Fail: Fail	Overall Compliance: No
		Severity Score: 25

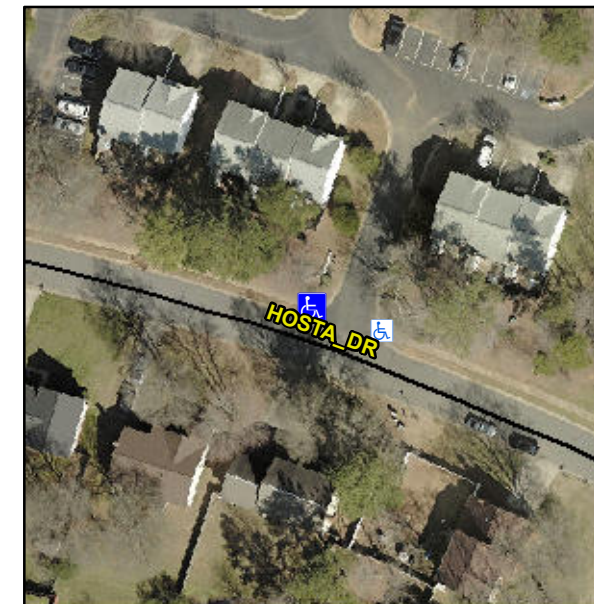
Not Found, R304.2.2

Compliance	Description	Data	Compliance	Description	Data
N/A	Ramp Length (in)	34.0	No	Ramp Slope (%)	12.2
Yes	Ramp Width (in)	48.0	Yes	Ramp XSlope (%)	1.8
N/A	Flare Type LT	N/A	N/A	Flare Type RT	N/A
N/A	Flare Slope LT (%)	N/A	N/A	Flare Slope RT (%)	N/A
N/A	Flare Traversable LT?	N/A	N/A	Flare Traversable RT?	N/A
N/A	Landing Length (in)	N/A	N/A	DWS Provided?	N/A
N/A	Landing Width (in)	N/A	N/A	DWS Contrast?	N/A
N/A	Landing Slope (%)	N/A	N/A	DWS Length (in)	N/A
N/A	Landing X Slope (%)	N/A	N/A	DWS Full Width?	N/A
N/A	Landing Curb? (Y/N)	N/A	N/A	DWS Offset (in)	N/A
N/A	Shared Landing?	N/A			
N/A	Gutter Ponding?	N/A	N/A	Gutter Slope (%)	N/A
N/A	Gutter Lip Ht (in)	N/A	N/A	Gutter X Slope (%)	N/A
N/A	Painted X Walk1?	No	N/A	Painted X Walk2?	No
	X Walk 1 Direction	To S		X Walk 2 Direction	To E
N/A	X Walk 1 Width (in)	N/A	N/A	X Walk 2 Width (in)	N/A
	X Walk 1 Slope (%)	1.7		X Walk 2 Slope (%)	4.7
	X Walk 1 X Slope (%)	4.0		X Walk 2 X Slope (%)	4.1

N/A	Ramp inside XWalk1?	N/A	N/A	Ramp inside XWalk2?	N/A
	Road Slope (%)	0.2	N/A	Clear Space?	N/A
	Road X Slope (%)	7.5	N/A	Clear Space to XWalk (in)	N/A
N/A	Any Obstructions?	N/A	N/A	Storm Grate/Utility Hazard?	N/A
	Obstruction Type			Storm Grate/Utility Type	
		N/A			N/A
			Yes	Surface Condition? (G/P)	Good

Remove & Replace Curb Ramp With Two New Directional Ramps or Equivalent.
