# Access Compliance Report

## Public Rights-of-Way

### (Curb Ramps)

Intersection ID: 10015093	Main Street: THE_PLAZA	Cross Street: LAKE_DR	Location: SW
ADA ID: 66B2A88EBE6A	Ramp Type: Perp	Initial Pass/Fail: Fail	Overall Compliance: No
Severity Score: 25			
Codes/Mitigation Info/Possible Solution		Field Measurements/Component Compliance

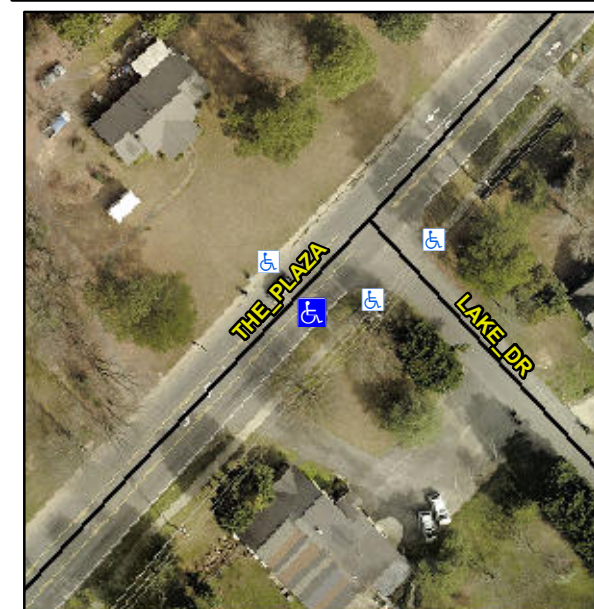
Compliance	Description	Data	Compliance	Description	Data
N/A	Ramp Length (in)	112.0	No	Ramp Slope (%)	12.0
Yes	Ramp Width (in)	60.5	Yes	Ramp XSlope (%)	0.8
N/A	Flare Type LT	N/A	N/A	Flare Type RT	N/A
N/A	Flare Slope LT (%)	N/A	N/A	Flare Slope RT (%)	N/A
N/A	Flare Traversable LT?	N/A	N/A	Flare Traversable RT?	N/A
N/A	Landing Length (in)	N/A	N/A	DWS Provided?	N/A
N/A	Landing Width (in)	N/A	N/A	DWS Contrast?	N/A
N/A	Landing Slope (%)	N/A	N/A	DWS Length (in)	N/A
N/A	Landing X Slope (%)	N/A	N/A	DWS Full Width?	N/A
N/A	Landing Curb? (Y/N)	N/A	N/A	DWS Offset (in)	N/A
N/A	Shared Landing?	N/A			
N/A	Gutter Ponding?	N/A	N/A	Gutter Slope (%)	N/A
N/A	Gutter Lip Ht (in)	1.0	N/A	Gutter X Slope (%)	N/A
N/A	Painted X Walk1?	No	N/A	Painted X Walk2?	N/A
	X Walk 1 Direction	To NW		X Walk 2 Direction	N/A
N/A	X Walk 1 Width (in)	N/A	N/A	X Walk 2 Width (in)	N/A
	X Walk 1 Slope (%)	4.5		X Walk 2 Slope (%)	N/A
	X Walk 1 X Slope (%)	0.2		X Walk 2 X Slope (%)	N/A

**Remove & Replace Entire Ramp.**

**R304.2.2**
