# Access Compliance Report

## Public Rights-of-Way

### (Curb Ramps)

Intersection ID: 9403	Main Street: EUREKA_ST	Cross Street: RUSH_WIND_DR	Location: SW
ADA ID: 66BF3185A172	Ramp Type: Para	Initial Pass/Fail: Fail	Overall Compliance: No
Severity Score: 50			
Codes/Mitigation Info/Possible Solution		Field Measurements/Component Compliance

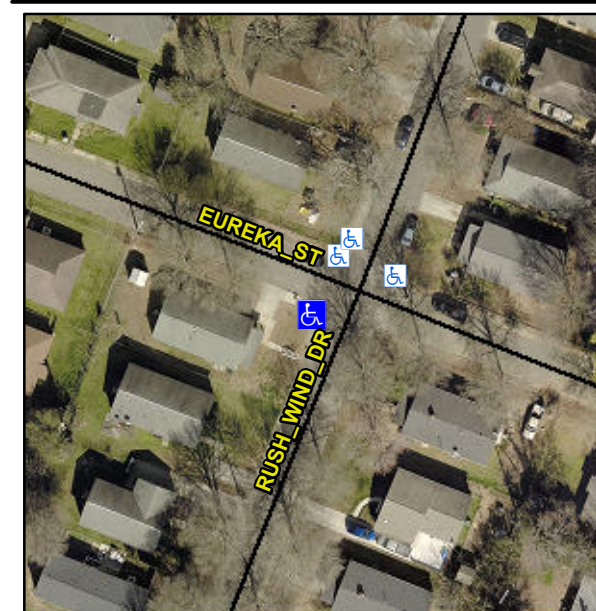
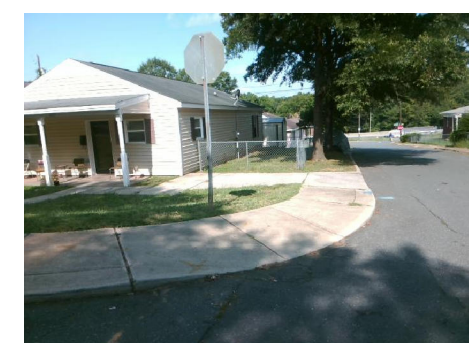
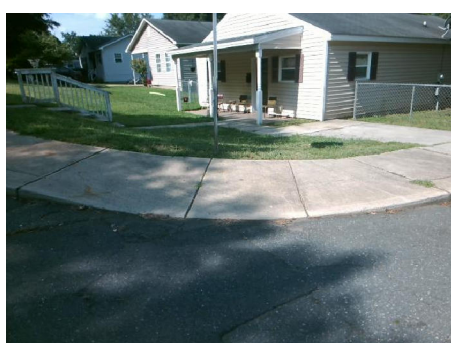
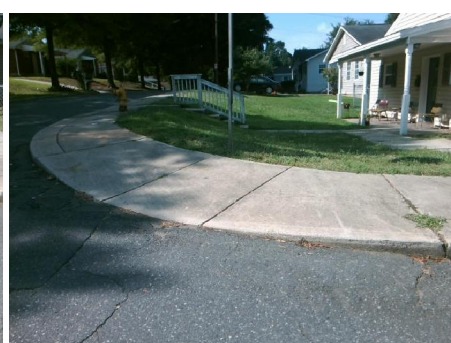
**NO CURB LINE, RT RP < 5%**

**R304.3.2, R304.5.3**

Compliance	Description	Data	Compliance	Description	Data
N/A	Ramp Length LT (in)	62.0	N/A	Ramp Length RT (in)	44.0
Yes	Ramp Width LT (in)	65.0	Yes	Ramp Width RT (in)	64.0
No	Ramp Slope LT (%)	14.6	Yes	Ramp Slope RT (%)	2.9
No	Ramp XSlope LT (%)	10.5	No	Ramp XSlope RT (%)	8.4
N/A	Landing Length (in)	N/A	N/A	DWS Provided?	N/A
N/A	Landing Width (in)	N/A	N/A	DWS Contrast?	N/A
N/A	Landing Slope (%)	N/A	N/A	DWS Length (in)	N/A
N/A	Landing X Slope (%)	N/A	N/A	DWS Full Width?	N/A
N/A	Landing Curb? (Y/N)	N/A	N/A	DWS Offset (in)	N/A
N/A	Shared Landing?	N/A			
N/A	Gutter Ponding?	N/A	N/A	Gutter Slope (%)	N/A
N/A	Gutter Lip Ht (in)	0.5	N/A	Gutter X Slope (%)	N/A
N/A	Painted X Walk1?	No	N/A	Painted X Walk2?	N/A
	X Walk 1 Direction	To NE		X Walk 2 Direction	N/A
N/A	X Walk 1 Width (in)	N/A	N/A	X Walk 2 Width (in)	N/A
	X Walk 1 Slope (%)	1.6		X Walk 2 Slope (%)	N/A
	X Walk 1 X Slope (%)	2.8		X Walk 2 X Slope (%)	N/A
N/A	Ramp inside XWalk1?	N/A	N/A	Ramp inside XWalk2?	N/A

Road Slope (%)	N/A	N/A	Clear Space?	N/A
	Road X Slope (%)	N/A	N/A	Clear Space to XWalk (in)	N/A
N/A	Any Obstructions?	N/A	N/A	Storm Grate/Utility Hazard?	N/A
	Obstruction Type			Storm Grate/Utility Type	
		N/A			N/A
			Yes	Surface Condition? (G/P)	Good
			N/A	Curb Slope (%)	N/A

**Remove & Replace Entire Ramp.**
