Access Compliance Report

Public Rights-of-Way

(Curb Ramps)

Intersection ID: 26451	Main Street: PARK_RD	Cross Street: KINGFISHER_DR	Location: SW
ADA ID: 66C32DFEC9E5	Ramp Type: PerpDiag	Initial Pass/Fail: Fail	Overall Compliance: No
Codes/Mitigation Info/Possible Solution		Field Measurements/Component Compliance	
Severity Score: 22.5

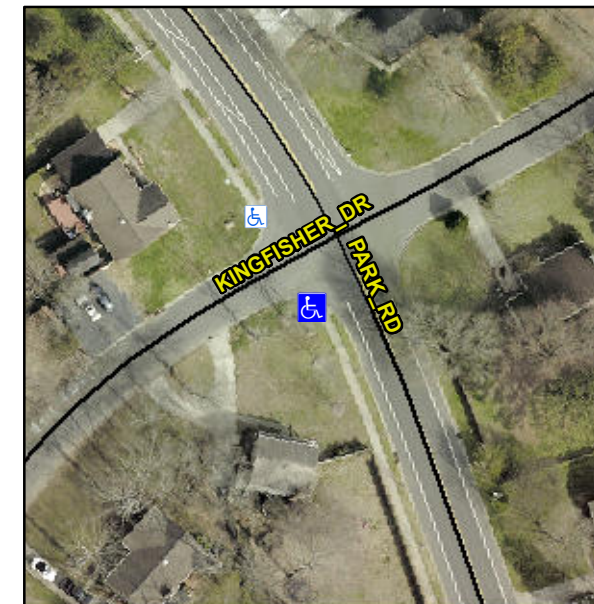
Not Found, R304.5.1, R304.2.2, R304.5.3

Compliance	Description	Data	Compliance	Description	Data
N/A	Ramp Length (in)	71.0	No	Ramp Slope (%)	10.7
No	Ramp Width (in)	46.5	No	Ramp XSlope (%)	4.3
N/A	Flare Type LT	N/A	N/A	Flare Type RT	N/A
N/A	Flare Slope LT (%)	N/A	N/A	Flare Slope RT (%)	N/A
N/A	Flare Traversable LT?	N/A	N/A	Flare Traversable RT?	N/A
N/A	Landing Length (in)	N/A	N/A	DWS Provided?	N/A
N/A	Landing Width (in)	N/A	N/A	DWS Contrast?	N/A
N/A	Landing Slope (%)	N/A	N/A	DWS Length (in)	N/A
N/A	Landing X Slope (%)	N/A	N/A	DWS Full Width?	N/A
N/A	Landing Curb? (Y/N)	N/A	N/A	DWS Offset (in)	N/A
N/A	Shared Landing?	N/A			
N/A	Gutter Ponding?	N/A	N/A	Gutter Slope (%)	N/A
N/A	Gutter Lip Ht (in)	N/A	N/A	Gutter X Slope (%)	N/A
N/A	Painted X Walk1?	No	N/A	Painted X Walk2?	No
	X Walk 1 Direction	To E		X Walk 2 Direction	To N
N/A	X Walk 1 Width (in)	N/A	N/A	X Walk 2 Width (in)	N/A
	X Walk 1 Slope (%)	3.0		X Walk 2 Slope (%)	6.2
	X Walk 1 X Slope (%)	5.2		X Walk 2 X Slope (%)	1.2

N/A	Ramp inside XWalk1?	N/A	N/A	Ramp inside XWalk2?	N/A
	Road Slope (%)	3.8	N/A	Clear Space?	N/A
	Road X Slope (%)	5.2	N/A	Clear Space to XWalk (in)	N/A
N/A	Any Obstructions?	N/A	N/A	Storm Grate/Utility Hazard?	N/A
	Obstruction Type			Storm Grate/Utility Type	
		N/A			N/A
			Yes	Surface Condition? (G/P)	Good

Remove & Replace Curb Ramp With Two New Directional Ramps or Equivalent.
