Access Compliance Report

Public Rights-of-Way

(Curb Ramps)

Intersection ID: 25815	Main Street: REA_RD	Cross Street: PINEVILLE-MATTHEWS_RD	Location: SW
ADA ID: 66C90E5CD1F1	Ramp Type: IslandPerp	Initial Pass/Fail: Fail	Overall Compliance: No
Severity Score: 21.25			
Codes/Mitigation Info/Possible Solution		Field Measurements/Component Compliance

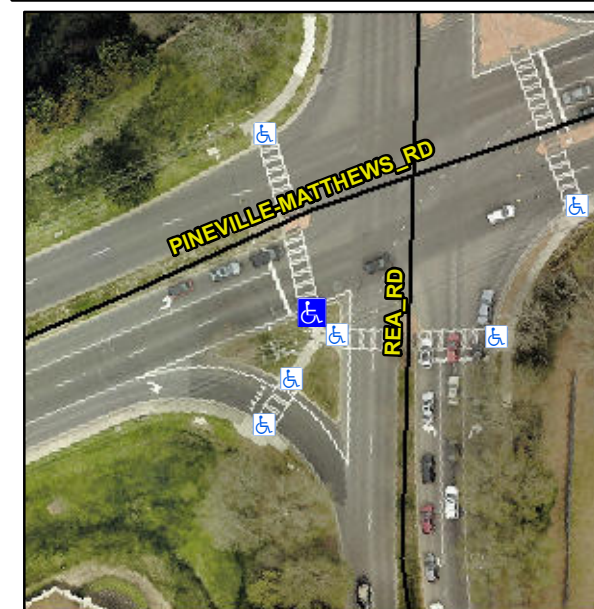
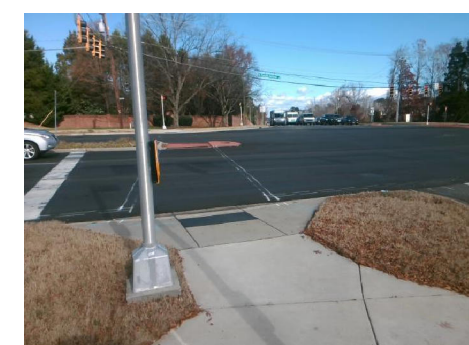
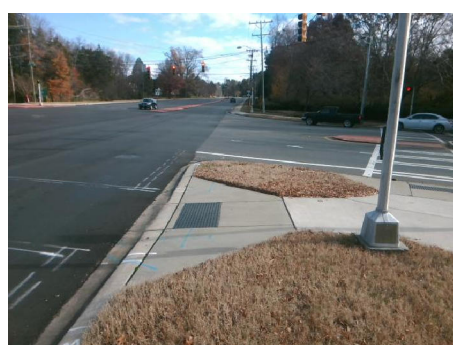
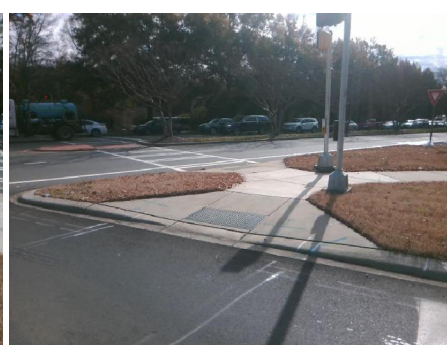
R304.5.1, R304.2.2

Compliance	Description	Data	Compliance	Description	Data
N/A	Ramp Length (in)	69.0	No	Ramp Slope (%)	8.5
No	Ramp Width (in)	47.5	Yes	Ramp XSlope (%)	1.1
N/A	Flare Type LT	N/A	N/A	Flare Type RT	N/A
N/A	Flare Slope LT (%)	N/A	N/A	Flare Slope RT (%)	N/A
N/A	Flare Traversable LT?	N/A	N/A	Flare Traversable RT?	N/A
N/A	Landing Length (in)	N/A	N/A	DWS Provided?	N/A
N/A	Landing Width (in)	N/A	N/A	DWS Contrast?	N/A
N/A	Landing Slope (%)	N/A	N/A	DWS Length (in)	N/A
N/A	Landing X Slope (%)	N/A	N/A	DWS Full Width?	N/A
N/A	Landing Curb? (Y/N)	N/A	N/A	DWS Offset (in)	N/A
N/A	Shared Landing?	N/A			
N/A	Gutter Ponding?	N/A	N/A	Gutter Slope (%)	N/A
N/A	Gutter Lip Ht (in)	N/A	N/A	Gutter X Slope (%)	N/A
N/A	Painted X Walk1?	Yes	N/A	Painted X Walk2?	N/A
	X Walk 1 Direction	To N		X Walk 2 Direction	N/A
N/A	X Walk 1 Width (in)	109.0	N/A	X Walk 2 Width (in)	N/A
	X Walk 1 Slope (%)	3.4		X Walk 2 Slope (%)	N/A
	X Walk 1 X Slope (%)	1.2		X Walk 2 X Slope (%)	N/A

N/A	Ramp inside XWalk1?	Yes	N/A	Ramp inside XWalk2?	N/A
	Road Slope (%)	N/A	N/A	Clear Space?	N/A
	Road X Slope (%)	N/A	N/A	Clear Space to XWalk (in)	N/A
N/A	Any Obstructions?	N/A	N/A	Storm Grate/Utility Hazard?	N/A
	Obstruction Type			Storm Grate/Utility Type	
		N/A			N/A
		Yes		Surface Condition? (G/P)	Good

Possible Solutions:

Remove & Replace Entire Ramp.

Total Cost: \$ 3400.00
