Access Compliance Report

Public Rights-of-Way

(Curb Ramps)

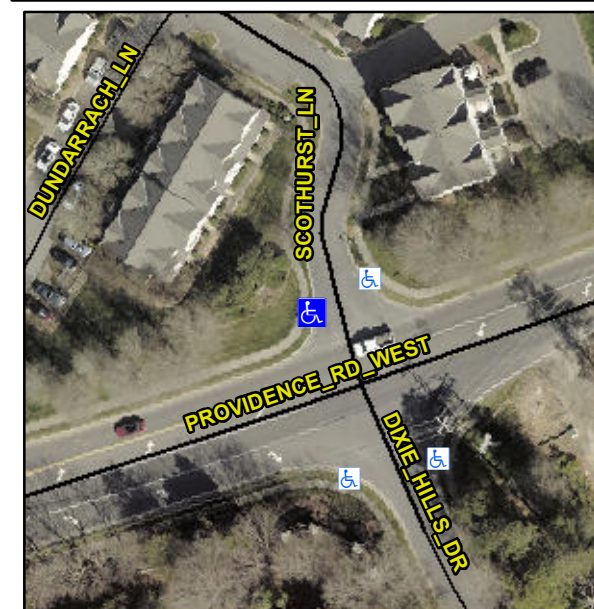
Intersection ID: 30632	Main Street: PROVIDENCE_RD_WEST	Cross Street: DIXIE_HILLS_DR	Location: NW
ADA ID: 66CDE0A3C44A	Ramp Type: PerpDiag	Initial Pass/Fail: Fail	Overall Compliance: No
Severity Score: 10			
Codes/Mitigation Info/Possible Solution		Field Measurements/Component Compliance

Not Found, R304.5.1, R304.5.3

Compliance	Description	Data	Compliance	Description	Data
N/A	Ramp Length (in)	43.0	Yes	Ramp Slope (%)	6.0
No	Ramp Width (in)	45.5	No	Ramp XSlope (%)	4.0
N/A	Flare Type LT	N/A	N/A	Flare Type RT	N/A
N/A	Flare Slope LT (%)	N/A	N/A	Flare Slope RT (%)	N/A
N/A	Flare Traversable LT?	N/A	N/A	Flare Traversable RT?	N/A
N/A	Landing Length (in)	N/A	N/A	DWS Provided?	N/A
N/A	Landing Width (in)	N/A	N/A	DWS Contrast?	N/A
N/A	Landing Slope (%)	N/A	N/A	DWS Length (in)	N/A
N/A	Landing X Slope (%)	N/A	N/A	DWS Full Width?	N/A
N/A	Landing Curb? (Y/N)	N/A	N/A	DWS Offset (in)	N/A
N/A	Shared Landing?	N/A			
N/A	Gutter Ponding?	N/A	N/A	Gutter Slope (%)	N/A
N/A	Gutter Lip Ht (in)	N/A	N/A	Gutter X Slope (%)	N/A
N/A	Painted X Walk1?	No	N/A	Painted X Walk2?	No
	X Walk 1 Direction	To S		X Walk 2 Direction	To E
N/A	X Walk 1 Width (in)	N/A	N/A	X Walk 2 Width (in)	N/A
	X Walk 1 Slope (%)	3.2		X Walk 2 Slope (%)	0.9
	X Walk 1 X Slope (%)	1.3		X Walk 2 X Slope (%)	5.2

N/A	Ramp inside XWalk1?	N/A	N/A	Ramp inside XWalk2?	N/A
	Road Slope (%)	5.3	N/A	Clear Space?	N/A
	Road X Slope (%)	3.1	N/A	Clear Space to XWalk (in)	N/A
N/A	Any Obstructions?	N/A	N/A	Storm Grate/Utility Hazard?	N/A
	Obstruction Type			Storm Grate/Utility Type	
		N/A			N/A
		Yes		Surface Condition? (G/P)	Good

Remove & Replace Curb Ramp With Two New Directional Ramps or Equivalent.
