Access Compliance Report

Public Rights-of-Way

(Curb Ramps)

Intersection ID: 48409	Main Street: GLADWYNE_PL	Cross Street: BRYN_ATHYN_CT	Location: SW
ADA ID: 66F384D71533	Ramp Type: Perp	Initial Pass/Fail: Fail	Overall Compliance: No
Severity Score: 13.75			
Codes/Mitigation Info/Possible Solution		Field Measurements/Component Compliance

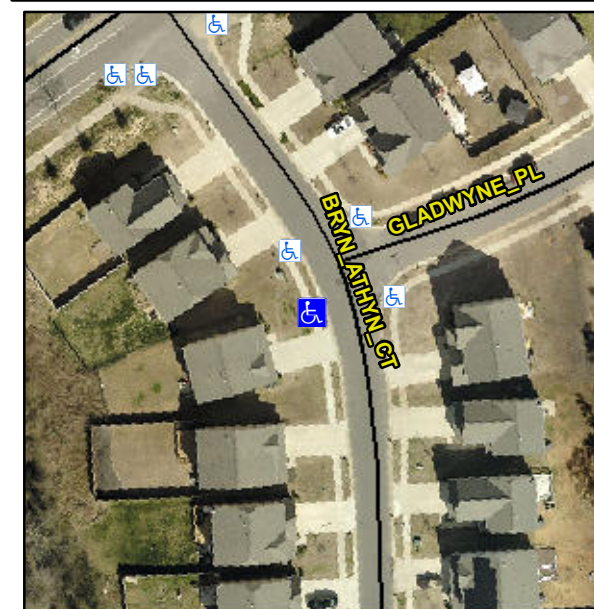
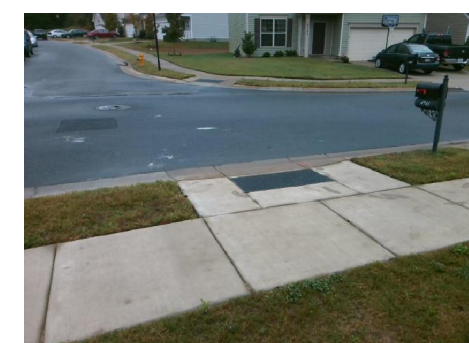
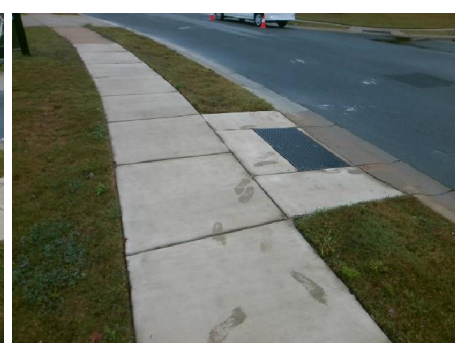
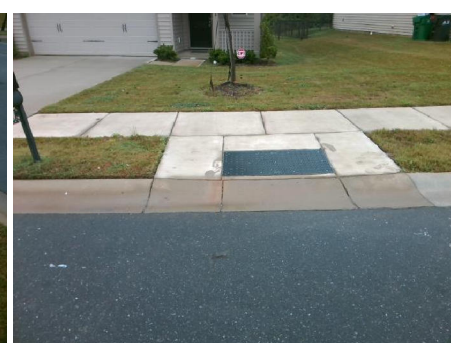
Not Found, R304.2.2, R304.5.3

Compliance	Description	Data	Compliance	Description	Data
N/A	Ramp Length (in)	48.0	No	Ramp Slope (%)	9.6
Yes	Ramp Width (in)	48.0	No	Ramp XSlope (%)	2.7
N/A	Flare Type LT	N/A	N/A	Flare Type RT	N/A
N/A	Flare Slope LT (%)	N/A	N/A	Flare Slope RT (%)	N/A
N/A	Flare Traversable LT?	N/A	N/A	Flare Traversable RT?	N/A
N/A	Landing Length (in)	N/A	N/A	DWS Provided?	N/A
N/A	Landing Width (in)	N/A	N/A	DWS Contrast?	N/A
N/A	Landing Slope (%)	N/A	N/A	DWS Length (in)	N/A
N/A	Landing X Slope (%)	N/A	N/A	DWS Full Width?	N/A
N/A	Landing Curb? (Y/N)	N/A	N/A	DWS Offset (in)	N/A
N/A	Shared Landing?	N/A			
N/A	Gutter Ponding?	N/A	N/A	Gutter Slope (%)	N/A
N/A	Gutter Lip Ht (in)	N/A	N/A	Gutter X Slope (%)	N/A
N/A	Painted X Walk1?	No	N/A	Painted X Walk2?	N/A
	X Walk 1 Direction	To E		X Walk 2 Direction	N/A
N/A	X Walk 1 Width (in)	N/A	N/A	X Walk 2 Width (in)	N/A
	X Walk 1 Slope (%)	0.9		X Walk 2 Slope (%)	N/A
	X Walk 1 X Slope (%)	2.2		X Walk 2 X Slope (%)	N/A

N/A	Ramp inside XWalk1?	N/A	N/A	Ramp inside XWalk2?	N/A
	Road Slope (%)	N/A	N/A	Clear Space?	N/A
	Road X Slope (%)	N/A	N/A	Clear Space to XWalk (in)	N/A
N/A	Any Obstructions?	N/A	N/A	Storm Grate/Utility Hazard?	N/A
	Obstruction Type			Storm Grate/Utility Type	
		N/A			N/A
			Yes	Surface Condition? (G/P)	Good

Possible Solutions:

Remove & Replace Entire Ramp.

Total Cost: \$ 1850.00
