# Access Compliance Report

## Public Rights-of-Way

### (Curb Ramps)

| Intersection ID: 10902 | Main Street: ALICE_AV | Cross Street: ELON_ST | Location: SE |

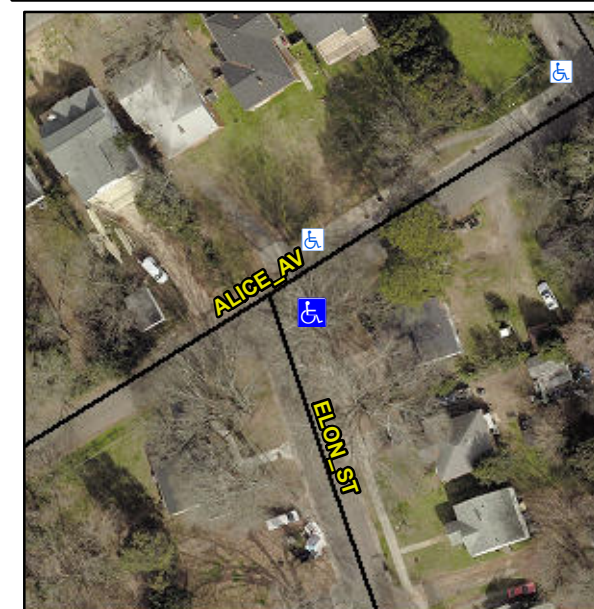
| ADA ID: 66F8B58AB80D | Ramp Type: Directional1 | Initial Pass/Fail: Pass | Overall Compliance: No |
| Severity Score: 5.25 | | | |

**R304.2.1, R304.2.2-Perp, R304.3.2-  
Para, R304.5.3, R305.2, R304.5.4**

| Compliance | Description | Data | Compliance | Description | Data |
|---|---|---|---|---|---|
| Yes | Ramp Slope (%) | 3.4 | No | Grade Break XSlope (%) | 2.6 |
| No | Landing Length (in) | 40.5 | Yes | DWS Provided? | Yes |
| No | Landing Slope (%) | 3.5 | Yes | DWS Length (in) | 24.5 |
| No | Landing X Slope (%) | 2.8 | Yes | DWS Full Width? | Yes |
| N/A | Shared Landing? | No | No | DWS Offset RT (in) | 9.0 |
| Yes | Gutter Ponding? | No | No | Gutter Slope (%) | 9.0 |

**Remove & Replace Entire Ramp.  
Remove & Replace Gutter.**
