Access Compliance Report

Public Rights-of-Way

(Curb Ramps)

Intersection ID: 49294	Main Street: ELIZABETH_CREST_LN	Cross Street: CREEKSIDE_PARK_RD	Location: SW
ADA ID: 67025AAD4188	Ramp Type: Perp	Initial Pass/Fail: Fail	Overall Compliance: No
Codes/Mitigation Info/Possible Solution		Field Measurements/Component Compliance	
Severity Score: 26.25

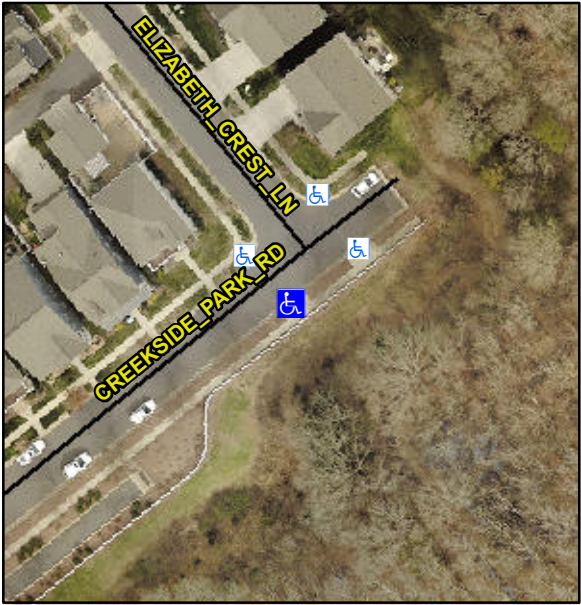
Possible Solutions:	Compliance	Description	Data	Compliance	Description	Data
	Remove & Replace Entire Ramp.	N/A	Ramp Length (in)	72.0	No	Ramp Slope (%)	13.2
		Yes	Ramp Width (in)	48.0	No	Ramp XSlope (%)	2.4
		N/A	Flare Type LT	N/A	N/A	Flare Type RT	N/A
		N/A	Flare Slope LT (%)	N/A	N/A	Flare Slope RT (%)	N/A
		N/A	Flare Traversable LT?	N/A	N/A	Flare Traversable RT?	N/A
		N/A	Landing Length (in)	N/A	N/A	DWS Provided?	N/A
		N/A	Landing Width (in)	N/A	N/A	DWS Contrast?	N/A
		N/A	Landing Slope (%)	N/A	N/A	DWS Length (in)	N/A
		N/A	Landing X Slope (%)	N/A	N/A	DWS Full Width?	N/A
<p>Surveyor Notes:</p> <p>N/A</p> <p>PROW/ADA:</p> <p>Not Found, R304.2.2, R304.5.3</p>		N/A	Landing Curb? (Y/N)	N/A	N/A	DWS Offset (in)	N/A
		N/A	Shared Landing?	N/A			
		N/A	Gutter Ponding?	N/A	N/A	Gutter Slope (%)	N/A
		N/A	Gutter Lip Ht (in)	N/A	N/A	Gutter X Slope (%)	N/A
		N/A	Painted X Walk1?	No	N/A	Painted X Walk2?	N/A
			X Walk 1 Direction	To NW		X Walk 2 Direction	N/A

N/A	X Walk 1 Width (in)	N/A	N/A	X Walk 2 Width (in)	N/A
			X Walk 1 Slope (%)	2.2		X Walk 2 Slope (%)	N/A
			X Walk 1 X Slope (%)	1.1		X Walk 2 X Slope (%)	N/A
		N/A	Ramp inside XWalk1?	N/A	N/A	Ramp inside XWalk2?	N/A
<p>Street 1 Name</p> <p>Stop Condition-Street 2</p> <p>Street 2 Name</p> <p>Stop Condition-Street 1</p>			Road Slope (%)	N/A	N/A	Clear Space?	N/A
			Road X Slope (%)	N/A	N/A	Clear Space to XWalk (in)	N/A
		N/A	Any Obstructions?	N/A	N/A	Storm Grate/Utility Hazard?	N/A
			Obstruction Type			Storm Grate/Utility Type	
				N/A			N/A
					Yes	Surface Condition? (G/P)	Good
Total Cost:		\$	1850.00
