Access Compliance Report

Public Rights-of-Way

(Curb Ramps)

Intersection ID: 21992	Main Street: WESTINGHOUSE_BV	Cross Street: S_TRYON_ST	Location: SW
ADA ID: 67089BA930E1	Ramp Type: PerpDiag	Initial Pass/Fail: Fail	Overall Compliance: No
		Severity Score: 12.5

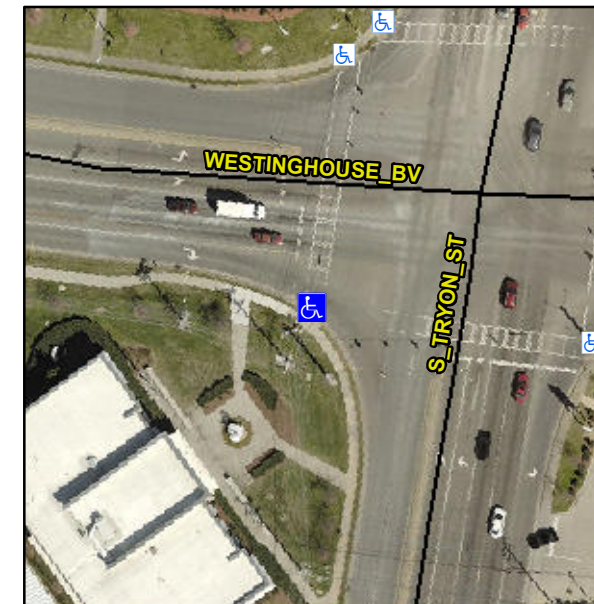
Compliance	Description	Data	Compliance	Description	Data
N/A	Ramp Length (in)	91.0	No	Ramp Slope (%)	9.6
Yes	Ramp Width (in)	48.0	Yes	Ramp XSlope (%)	2.0
N/A	Flare Type LT	N/A	N/A	Flare Type RT	N/A
N/A	Flare Slope LT (%)	N/A	N/A	Flare Slope RT (%)	N/A
N/A	Flare Traversable LT?	N/A	N/A	Flare Traversable RT?	N/A
N/A	Landing Length (in)	N/A	N/A	DWS Provided?	N/A
N/A	Landing Width (in)	N/A	N/A	DWS Contrast?	N/A
N/A	Landing Slope (%)	N/A	N/A	DWS Length (in)	N/A
N/A	Landing X Slope (%)	N/A	N/A	DWS Full Width?	N/A
N/A	Landing Curb? (Y/N)	N/A	N/A	DWS Offset (in)	N/A
N/A	Shared Landing?	N/A			
N/A	Gutter Ponding?	N/A	N/A	Gutter Slope (%)	N/A
N/A	Gutter Lip Ht (in)	N/A	N/A	Gutter X Slope (%)	N/A
N/A	Painted X Walk1?	Yes	N/A	Painted X Walk2?	Yes
	X Walk 1 Direction	To E		X Walk 2 Direction	To N
N/A	X Walk 1 Width (in)	108.0	N/A	X Walk 2 Width (in)	111.0
	X Walk 1 Slope (%)	2.9		X Walk 2 Slope (%)	3.1
	X Walk 1 X Slope (%)	3.8		X Walk 2 X Slope (%)	2.3

N/A	Ramp inside XWalk1?	Yes	N/A	Ramp inside XWalk2?	Yes
	Road Slope (%)	1.5	N/A	Clear Space?	N/A
	Road X Slope (%)	3.8	N/A	Clear Space to XWalk (in)	N/A
N/A	Any Obstructions?	N/A	N/A	Storm Grate/Utility Hazard?	N/A
	Obstruction Type			Storm Grate/Utility Type	
		N/A			N/A
		Yes		Surface Condition? (G/P)	Good

Possible Solutions:

Remove & Replace Curb Ramp With Two New Directional Ramps or Equivalent.

R304.2.2
