# Access Compliance Report

## Public Rights-of-Way

### (Curb Ramps)

Intersection ID: 31905	Main Street: PALOMAR_MOUNTAIN_DR	Cross Street: STOWE_DERBY_DR	Location: NE
ADA ID: 67091258DF15	Ramp Type: BlendTrans2	Initial Pass/Fail: Fail	Overall Compliance: No
Severity Score: 10			
Codes/Mitigation Info/Possible Solution		Field Measurements/Component Compliance

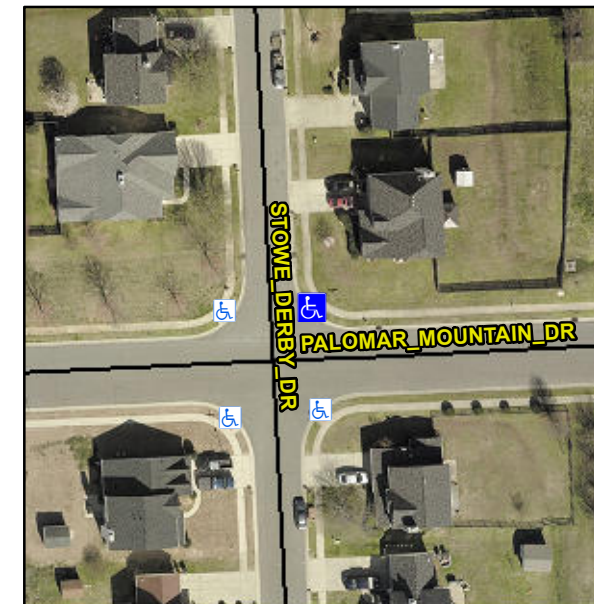
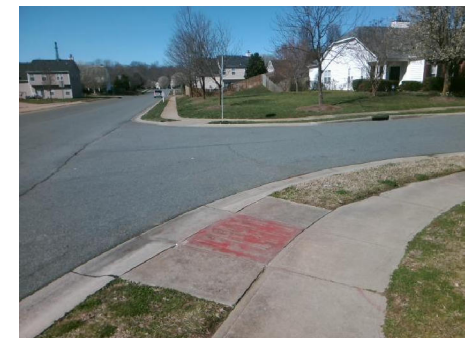
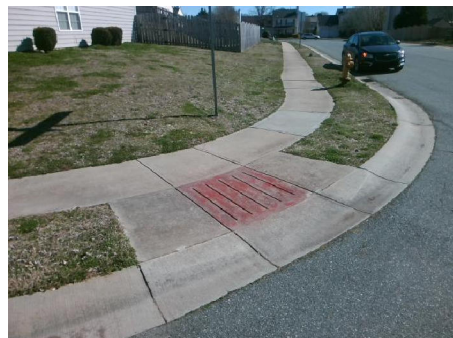
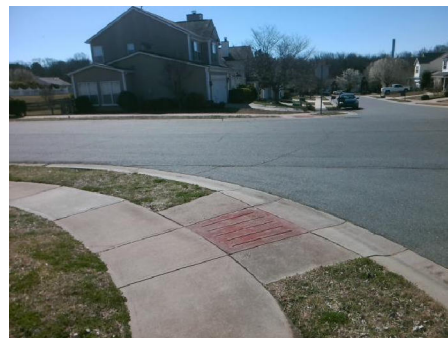
**Not Found, R304.5.1, R304.5.3**

Compliance	Description	Data	Compliance	Description	Data
N/A	Ramp Length (in)	94.0	Yes	BlendTrans Slope (%)	1.9
No	Ramp Width (in)	36.0	No	BlendTrans XSlope (%)	2.3
N/A	Flare Type LT	N/A	N/A	Flare Type RT	N/A
N/A	Flare Slope LT (%)	N/A	N/A	Flare Slope RT (%)	N/A
N/A	Flare Traversable LT?	N/A	N/A	Flare Traversable RT?	N/A
N/A	Landing Length (in)	N/A	N/A	DWS Provided?	N/A
N/A	Landing Width (in)	N/A	N/A	DWS Contrast?	N/A
N/A	Landing Slope (%)	N/A	N/A	DWS Length (in)	N/A
N/A	Landing X Slope (%)	N/A	N/A	DWS Full Width?	N/A
N/A	Landing Curb? (Y/N)	N/A	N/A	DWS Offset (in)	N/A
N/A	Shared Landing?	N/A			
N/A	Gutter Ponding?	N/A	N/A	Gutter Slope (%)	N/A
N/A	Gutter Lip Ht (in)	N/A	N/A	Gutter X Slope (%)	N/A
N/A	Painted X Walk1?	No	N/A	Painted X Walk2?	No
	X Walk 1 Direction	To W		X Walk 2 Direction	To S
	X Walk 1 Width (in)	N/A		X Walk 2 Width (in)	N/A
	X Walk 1 Slope (%)	0.9		X Walk 2 Slope (%)	0.1
	X Walk 1 X Slope (%)	0.1		X Walk 2 X Slope (%)	1.8

N/A	Ramp inside XWalk1?	N/A	N/A	Ramp inside XWalk2?	N/A
	Road Slope (%)	0.4		Clear Space?	N/A
	Road X Slope (%)	1.9	N/A	Clear Space to XWalk (in)	N/A
N/A	Any Obstructions?	N/A	N/A	Storm Grate/Utility Hazard?	N/A
	Obstruction Type			Storm Grate/Utility Type	
		N/A			N/A
			Yes	Surface Condition? (G/P)	Good
			No	Curb Slope (%)	5.4

**Remove & Replace Curb Ramp With Two New Directional Ramps or Equivalent.**
