# Access Compliance Report

## Public Rights-of-Way

### (Curb Ramps)

| Intersection ID: 7057 | Main Street: KENDRICK_AV | Cross Street: STATESVILLE_RD | Location: SE |

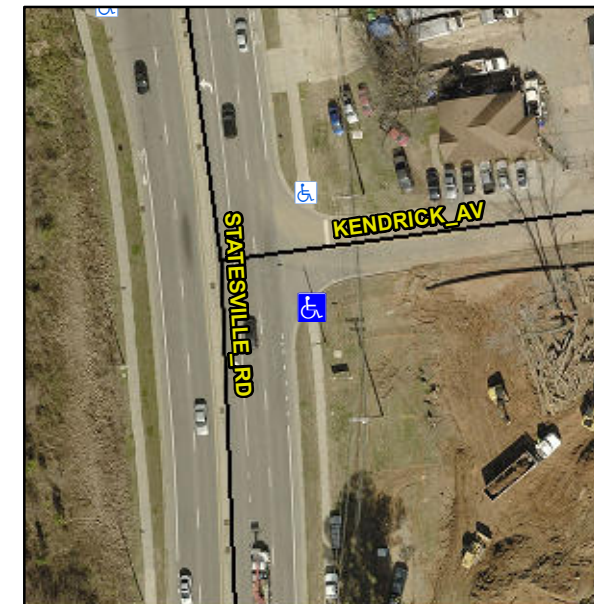
| | | Severity Score: 7.5 | |

**CRACK LT FL**

**R304.5.3, R302.7, R302.7.2**

**Remove & Replace Entire Ramp.  
Grind Gutter Lip.**

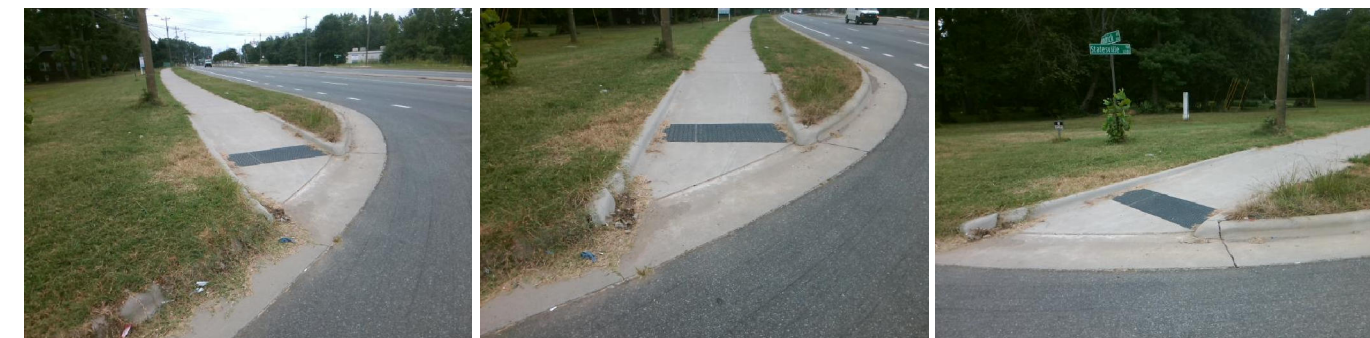
| Compliance | Description | Data | Compliance | Description | Data |
|---|---|---|---|---|---|
| Yes | Ramp Width (in) | 66.0 | No | Grade Break Slope (%) | 6.5 |
| No | Landing X Slope (%) | 2.9 | Yes | DWS Full Width? | Yes |
